Site	Wongawilli Colliery		
Type	Report	Date Published	25/02/2020
Doc Title	Annual Review/Annual Environmental Management Report

Wongawilli Colliery Nebo Area Project Approval (MP 09_161)

ANNUAL REVIEW/ANNUAL ENVIRONMENTAL MANAGEMENT REPORT (1 JULY 2018 – 30 JUNE 2019)

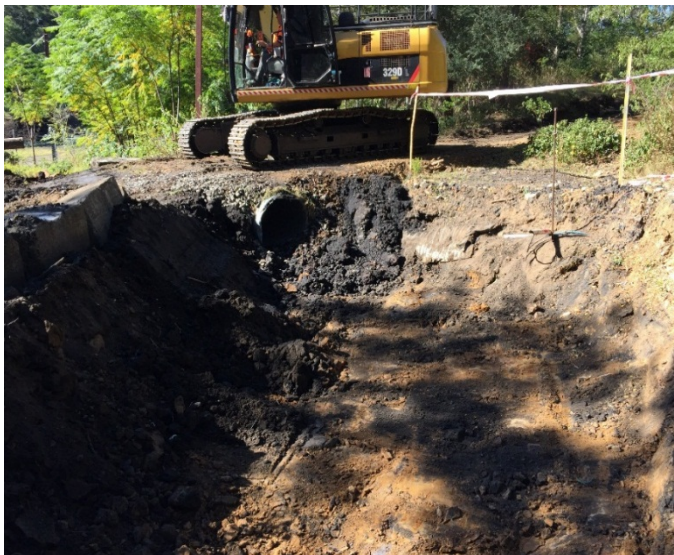
Figure 5.1: Dissipation Dam

Dissipation Dam: The small basin was desilted (**Figure 5.1**).

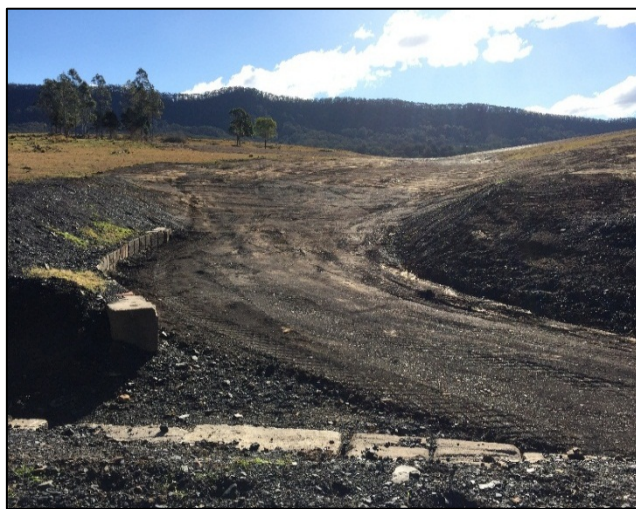
Figure 5.2: Remediation Work May 2018

Emplacement Erosion Scar: A significant amount of erosion has occurred on the eastern side of the emplacement area over several years. Remediation work was completed with in May 2018 (**Figure 5.2**). **Figure 5.3** shows the area one year after the completion of remediation.

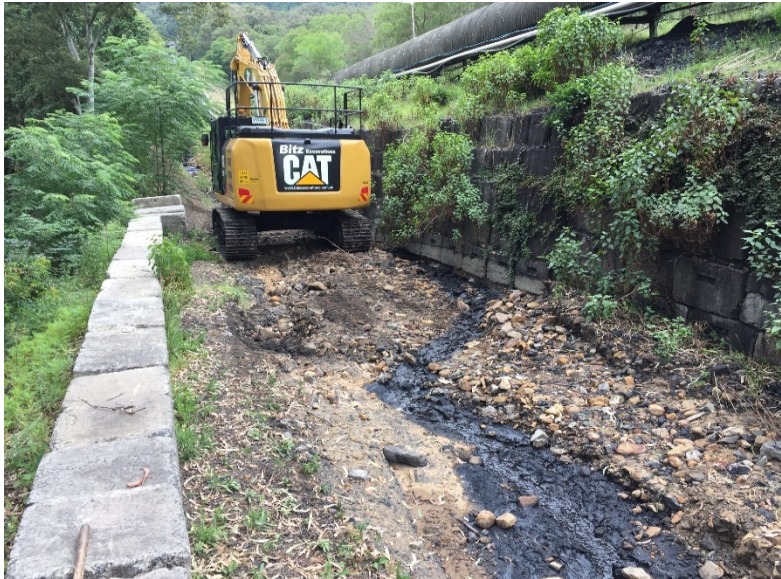
Figure 5.4: Decline Drain Maintenance

Decline Drain: The drain has been maintained during the reporting period (**Figure 5.4**). Loose material is pulled out of the drain and the drain batters are repaired and shaped again.

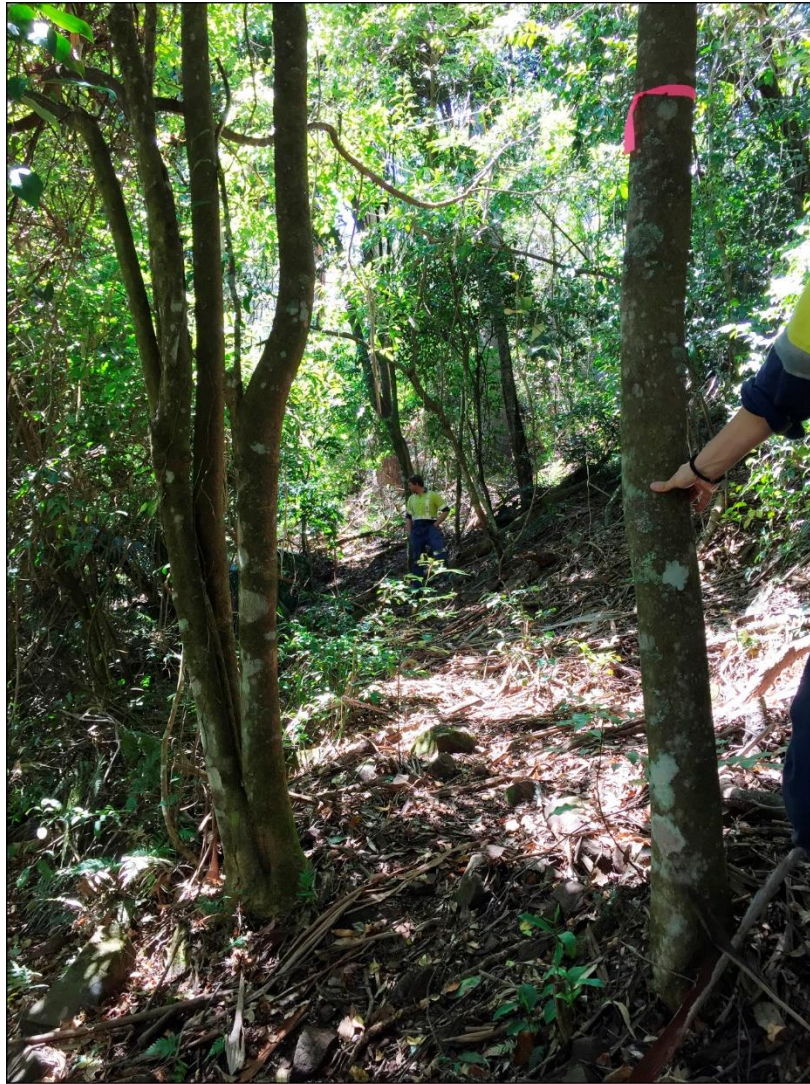
Maximum strains calculated between individual pegs along NM4 Line from the 2D data are 0.9mm/m in compression and 0.6mm/m in tension.

The angle of draw, to the 20mm vertical subsidence to the west of N1 Panel is estimated to be approximately 18°. In the east, the point of 20mm subsidence is located above the extracted void of N5 Panel due to reduced panel width and the low levels of subsidence over N5 Panel.

a) Looking west above N5 Panel.

Figure 4: Examples of surface terrain along NM4 subsidence monitoring line.

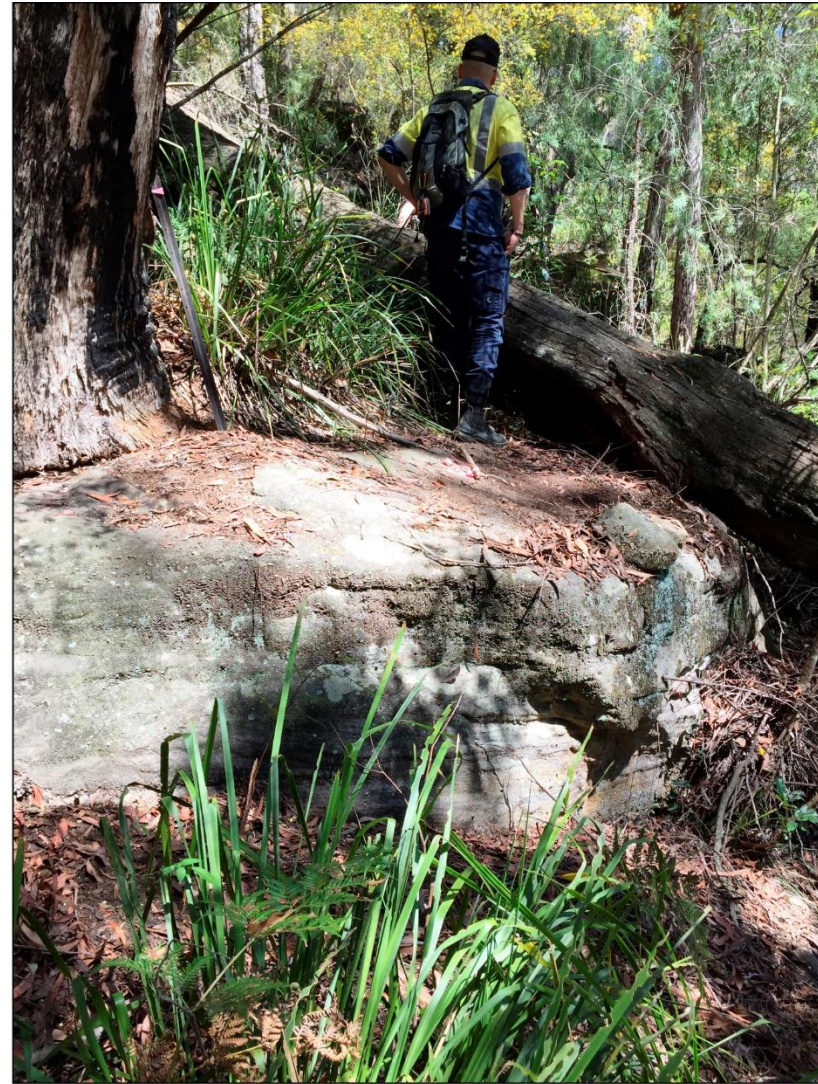
b) Looking west above N1 Panel.

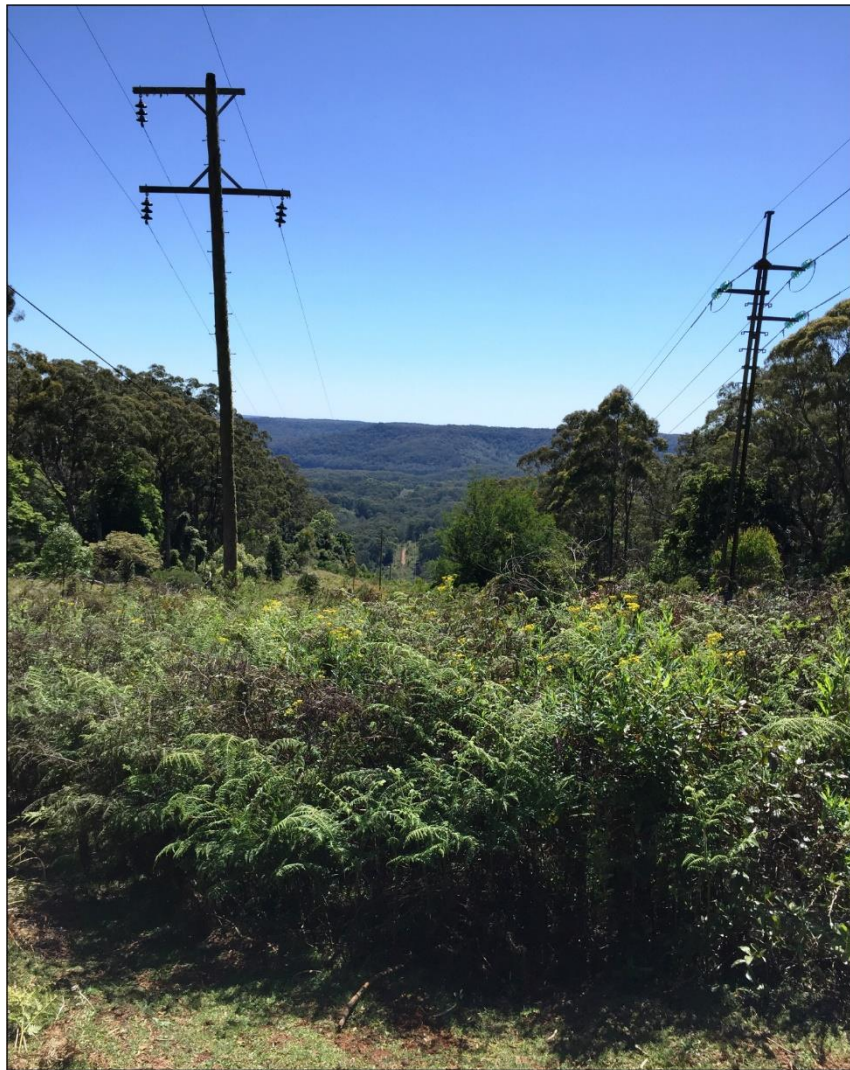
Figure 6: Looking to North with Power Pole 22 on left.

PP21 and PP22 are the nearest power poles on this line to the areas of secondary extraction in N1 and N5 Panels. These two poles are located more than 130m horizontally to the southeast of N5 and are positioned above pillars or larger areas of solid coal. Figure 6 shows PP22 looking north, with the mine-owned 33kV powerline on the right.

From the baseline survey of March 2013, the poles were surveyed in July 2014 after Longwall N2, in September 2018 during the mining of N3 and N1 Panels and again in November 2019, some 10 months after mining in N5, and 8 months after all mining had finished.

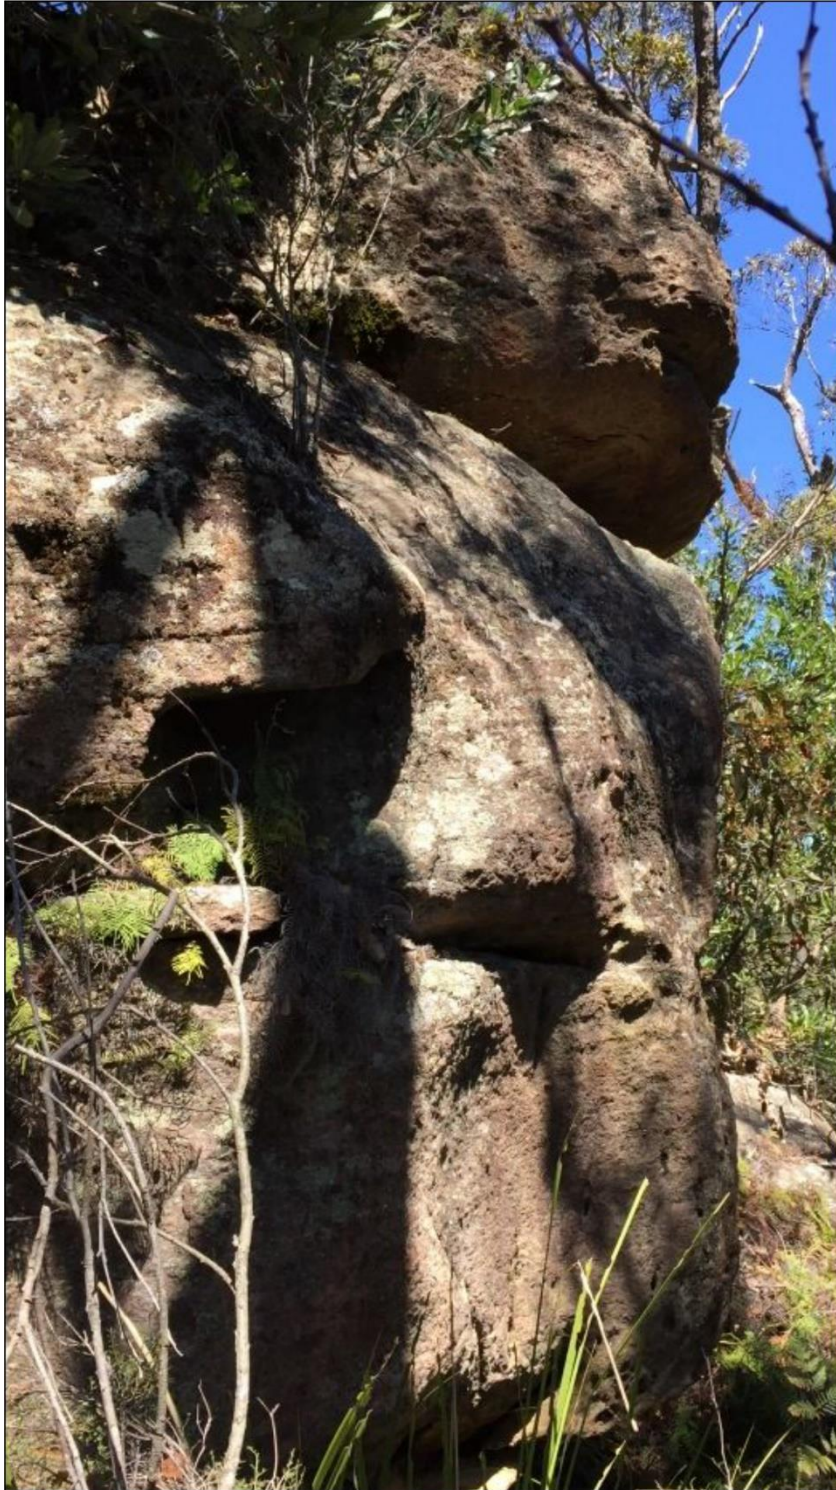
Figure 8: Typical rock outcrop near western edge of N1 Panel.

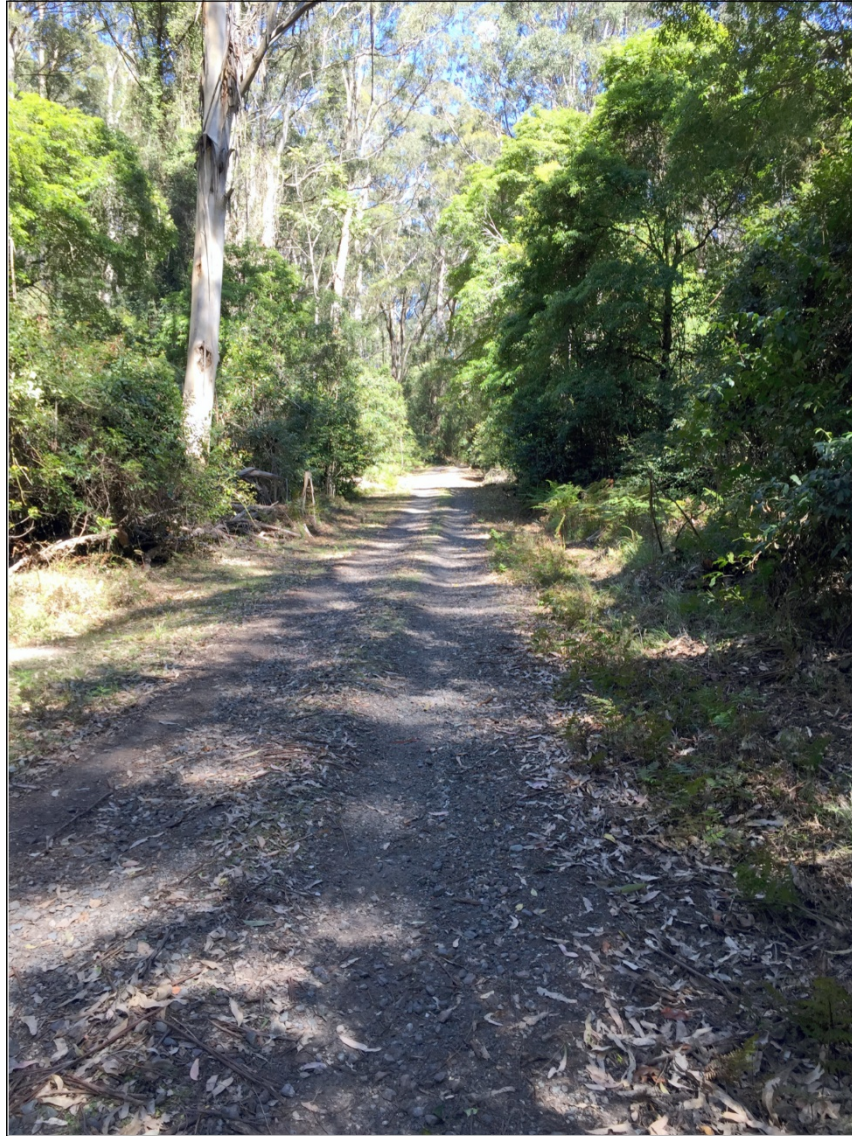
The subsidence movements measured are of low magnitude. However, these need to be considered in the context of survey techniques and the expected survey tolerances outlined in Table 5.2 – Subsidence Monitoring and Management, Appendix A – Monitoring Program and Trigger Action Response Plans (TARPS) and Appendix C – Monitoring Methods and Accuracy of the Nebo Longwalls 1-6 Subsidence Monitoring Plan.

a) Looking west above N3 Panel.

Figure 3: Surface along NM3 subsidence monitoring line.

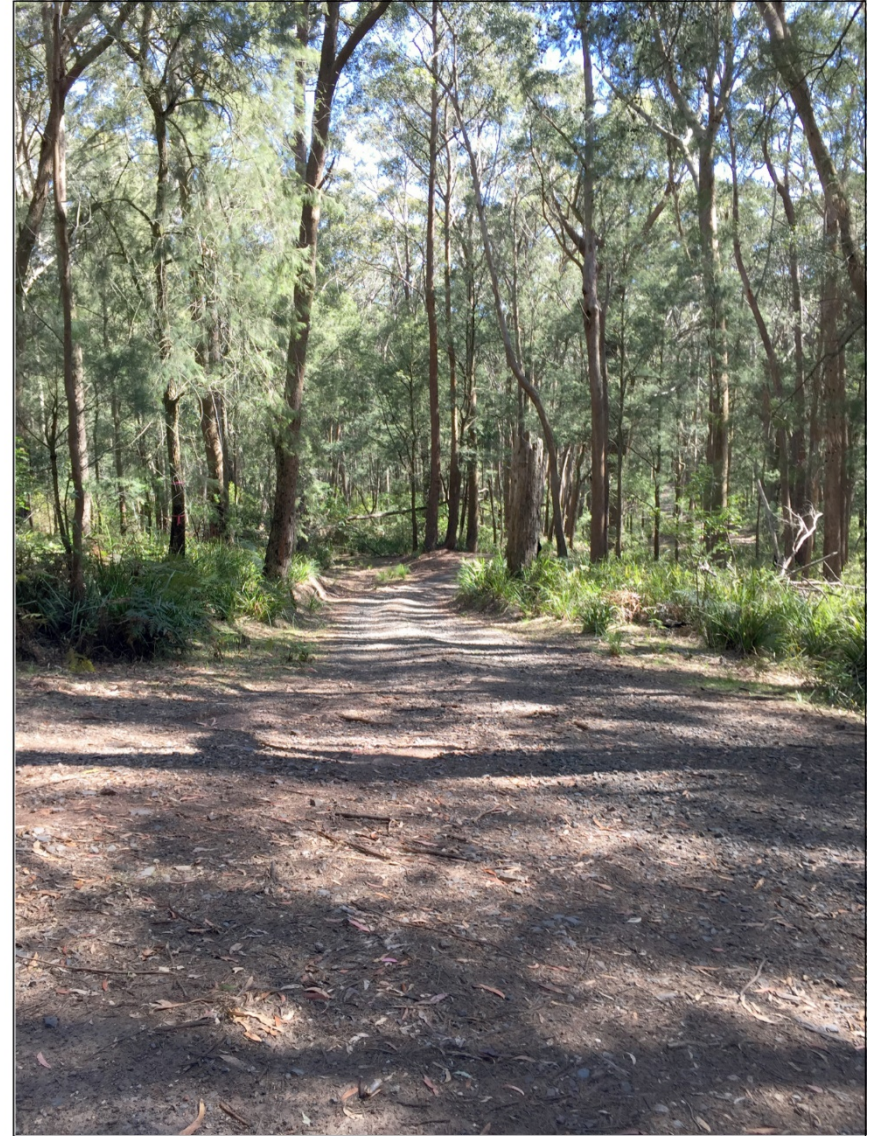
**b) Looking north above LWN2-N3 chain pillars.
(Location of maximum subsidence)**

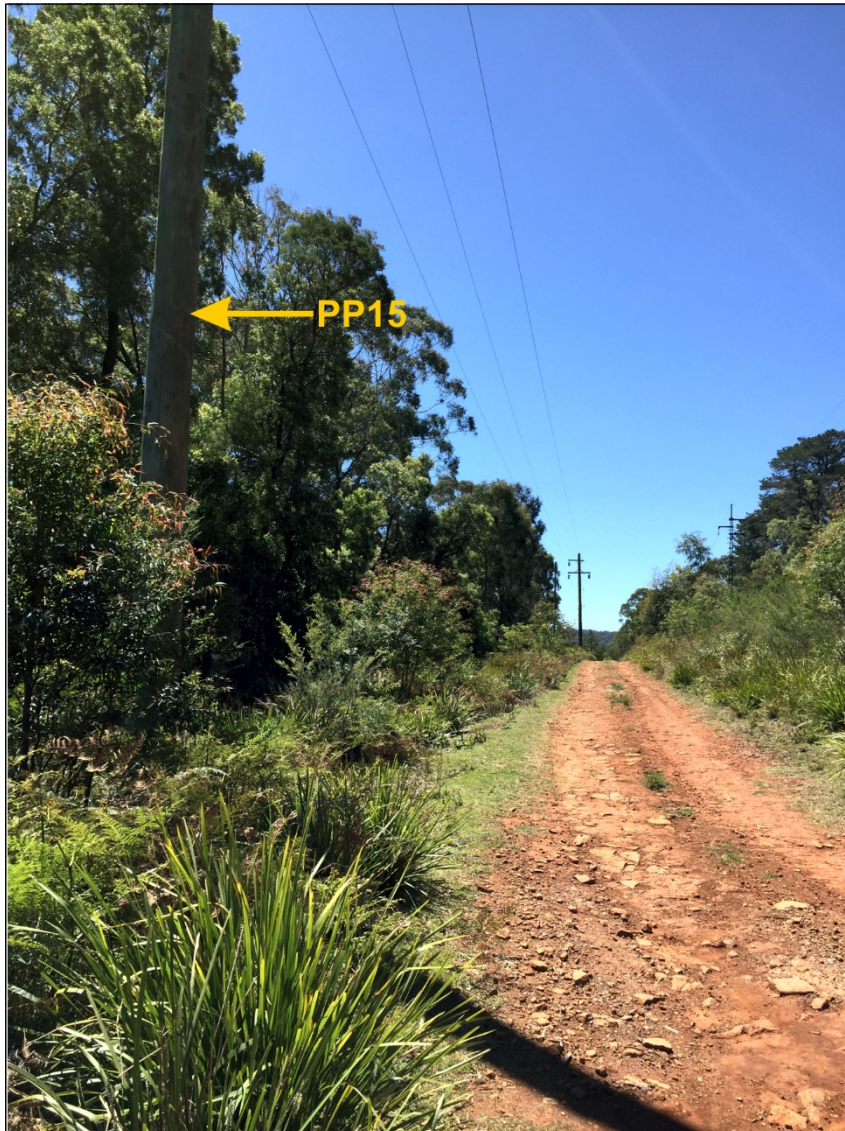
The nearest power poles on this line to Longwall N2 and N3 Panels are PP15, located 110m north of where the Longwall N2 stopped and PP16 located 150m to the west of Longwall N2. Both these locations are above solid coal. PP15 has been replaced since Longwall N2 finished as part of regular maintenance on this transmission line. Figure 5 shows the powerlines with PP15 and PP16 identified.

From the baseline survey of March 2013, the poles were surveyed in July 2014 after Longwall N2, in September 2018 during the mining of N3 Panel and again in November 2019. Although PP16 is expected to have experienced up to 30mm of horizontal and vertical subsidence, comparison of the surveys of all poles indicates only low-level movements within survey tolerance. No significant differences in tilt, vertical subsidence or horizontal movement were measured.

a) Looking north - PP15 in foreground on left.

Figure 5: Surface along 33kV powerlines easement.

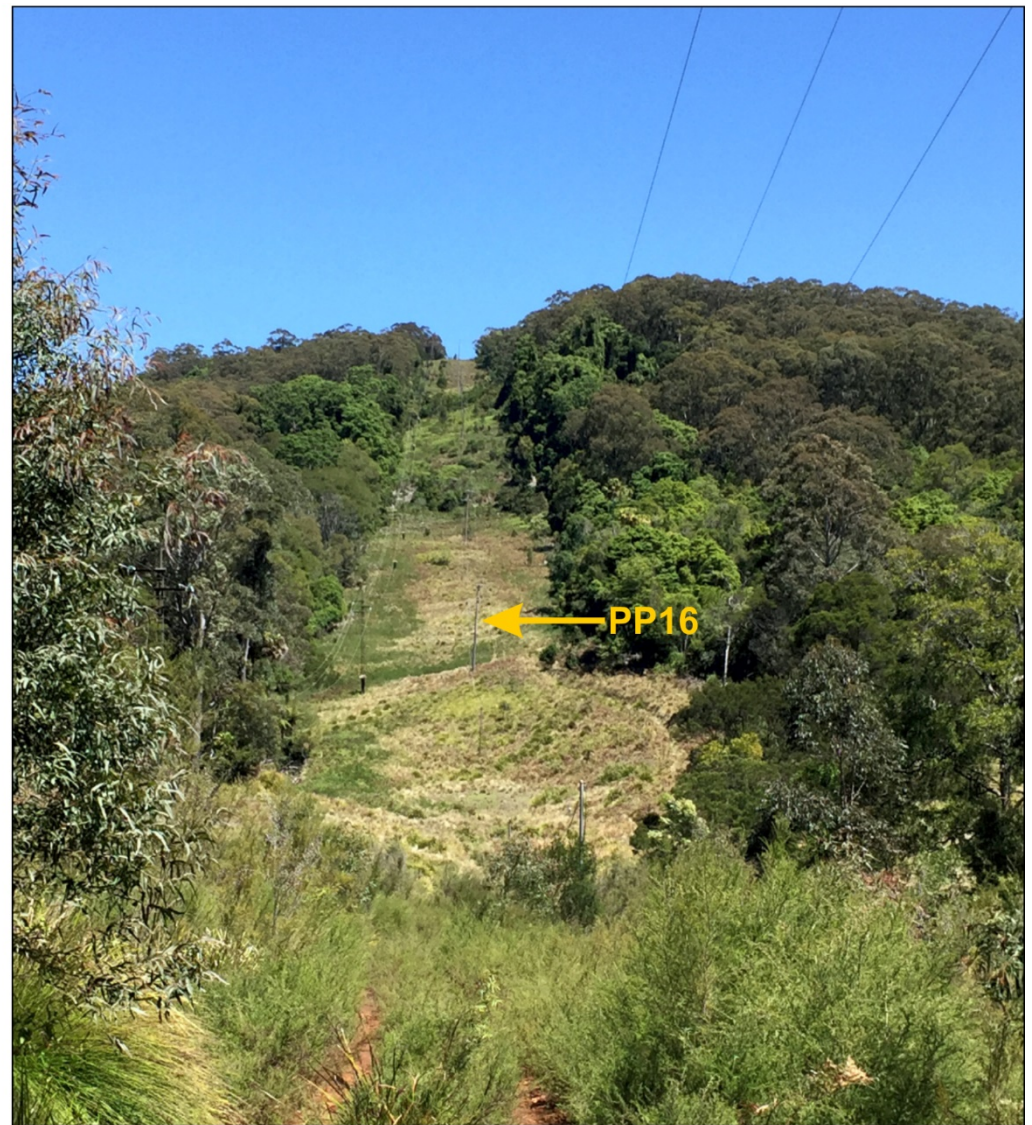
b) Looking south from PP15 - PP16 in middle ground on right.
