GUJARAT NRE Wonga Pty Ltd

WONGAWILLI COLLIERY LONGWALL 15 END OF PANEL REPORT

March 2013

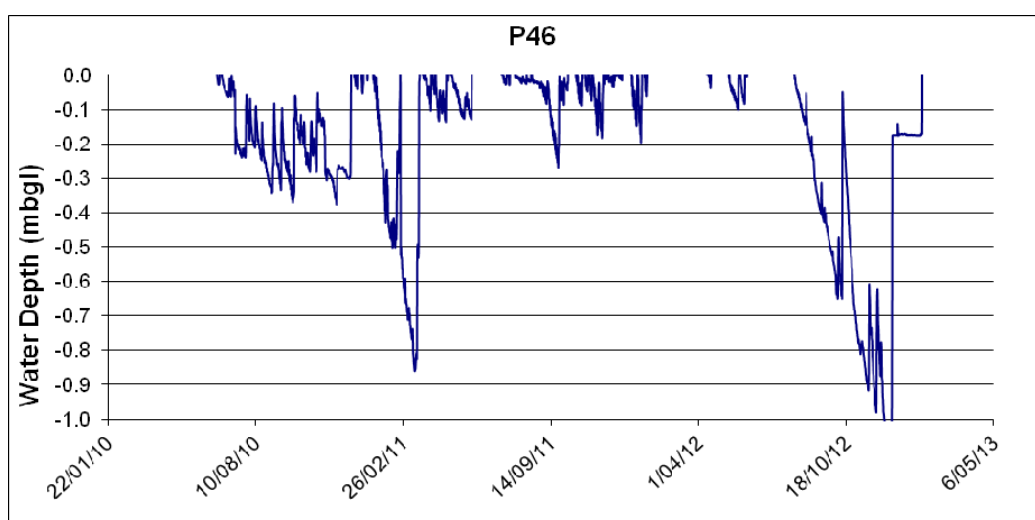
Figure 3: P46 Shallow Groundwater Level

Water level monitoring data from the remaining suite of shallow groundwater monitoring sites showed a gradual drop in level due to limited rainfall during 2012. No significant drop in level was recorded.

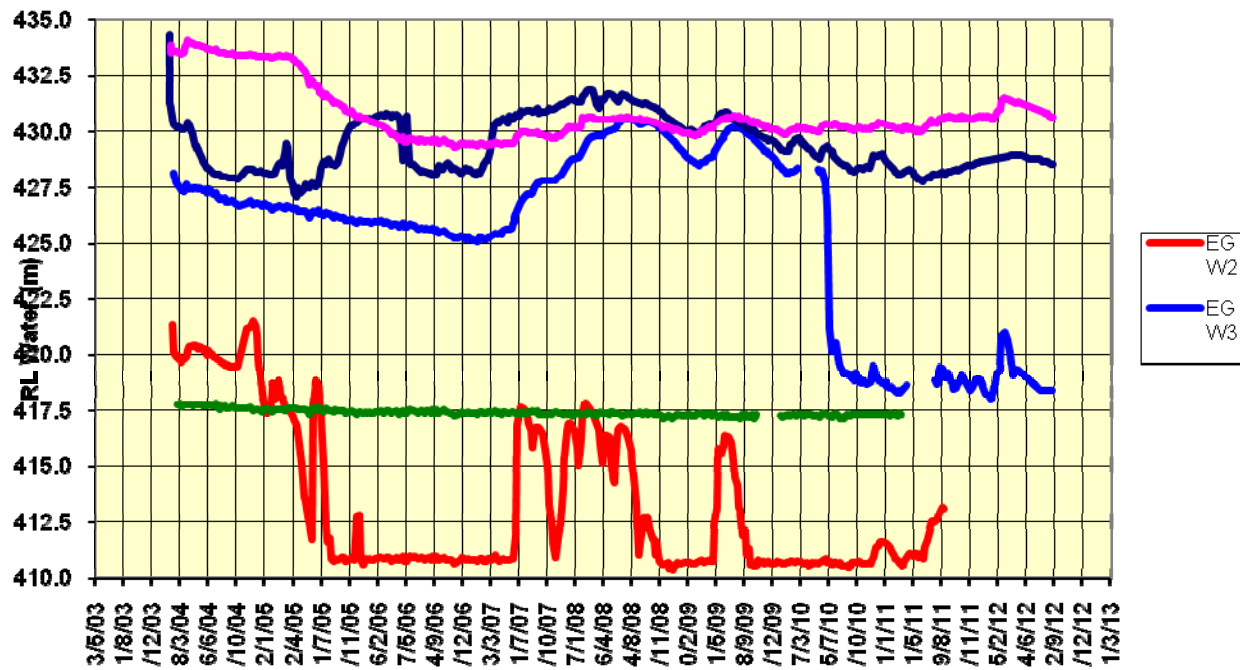
Figure 5: EGW Series Borehole Water Level

Figure 5 contains groundwater levels from the EGW series groundwater bores. The water level in EGW3, which lies directly above Longwall 11, dropped by 8.92 metres around June 2010 after it was undermined. No significant fall in the other EGW series piezometers has occurred.
