**GUJARAT NRE FCGL Pty Ltd**

## **WONGAWILLI COLLIERY LONGWALL 20 END OF PANEL REPORT**

**August 2012**

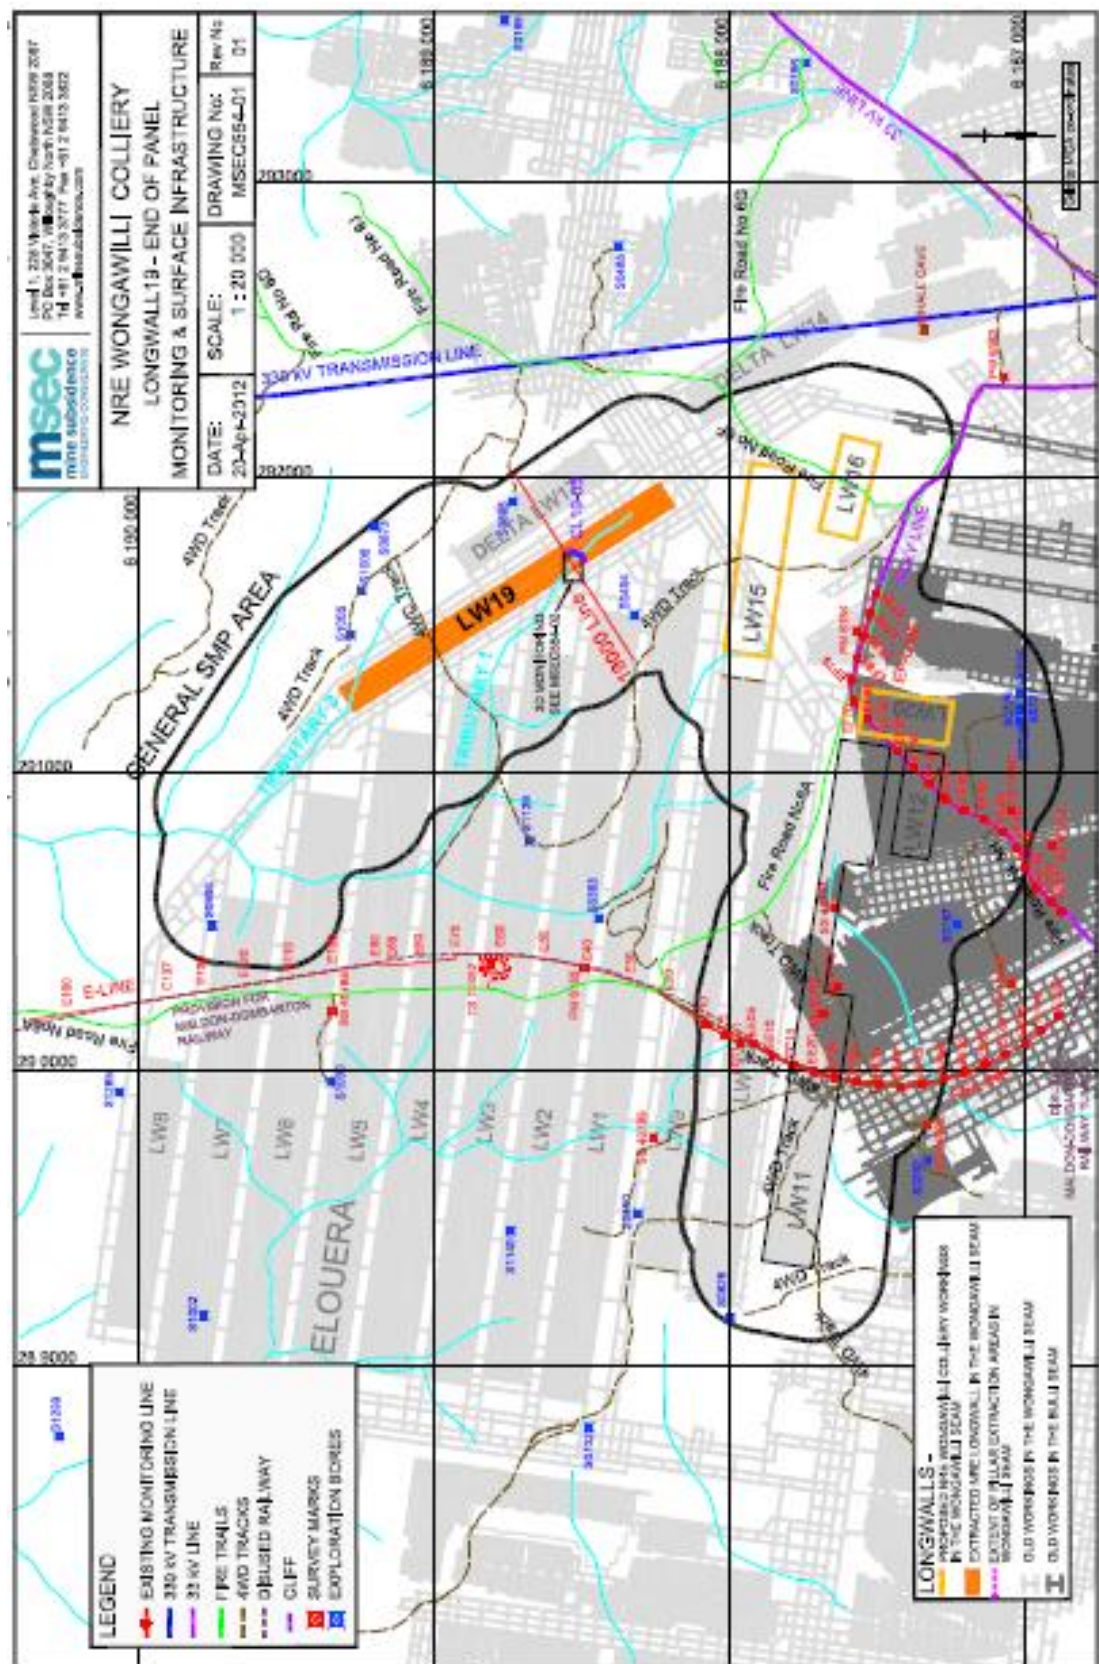
**Figure 1: Longwall 20, Monitoring and Surface Infrastructure (Source – MSEC 554-01)**

The subsidence movements resulting from the extraction of Longwall 20 were measured along the EF survey line which is a 2D monitoring line. The locations of the longwalls at the Colliery and the monitoring lines are shown in **Figure 1**. A comparison of the observed and predicted movements resulting from the extraction of Longwall 20 has been prepared by MSEC and is provided in full in **Attachment A**.

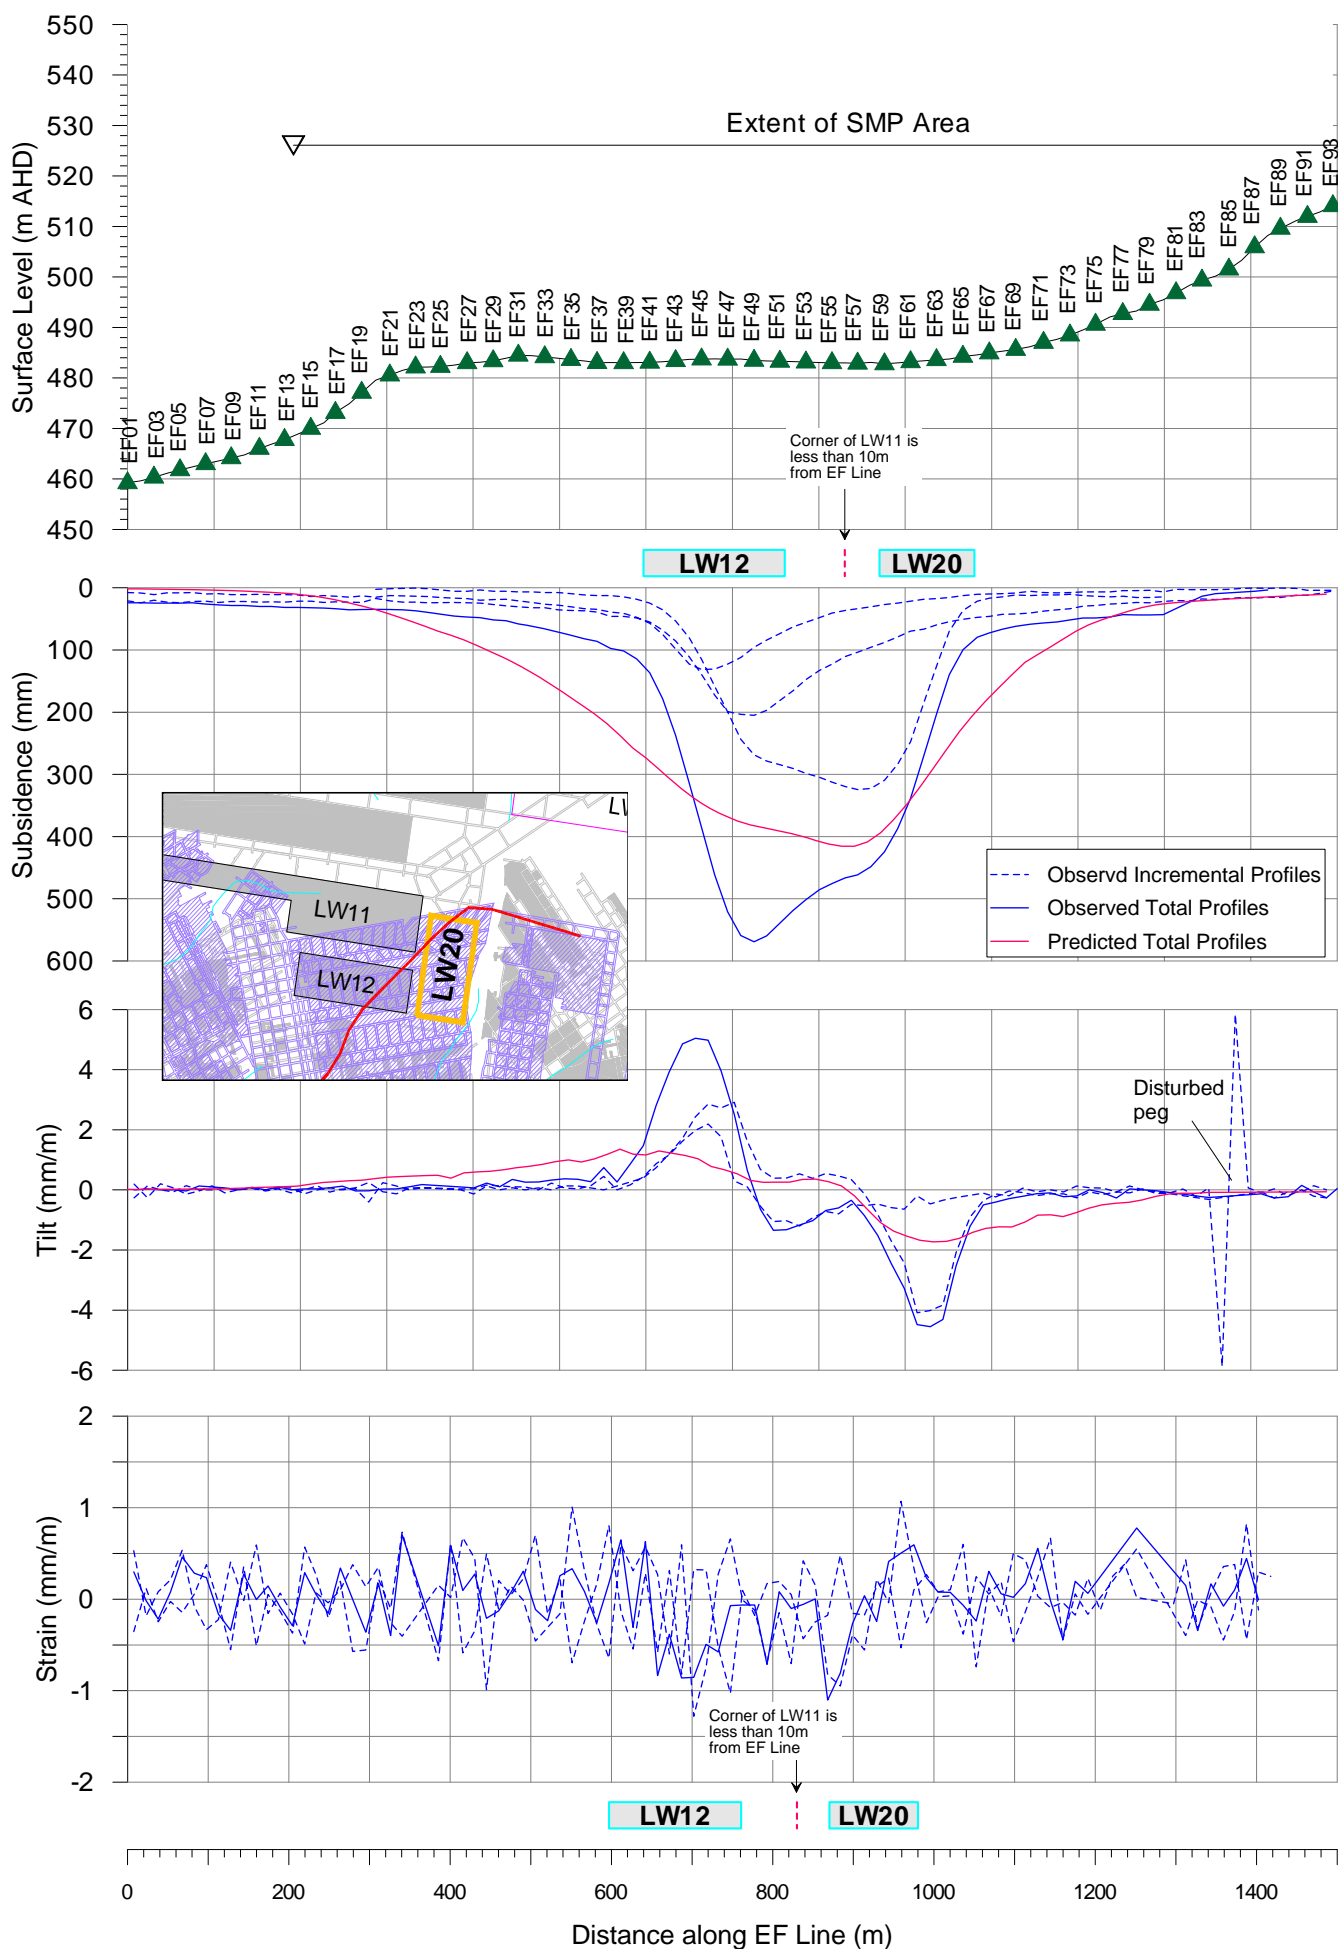
# Observed and Predicted Profiles of Subsidence, Tilt and Strain along the EF-Line resulting from LW20 Extraction

The maximum observed total subsidence due to the extraction of LW12, 11 and 20 is 570 mm at survey mark EF49, which is greater than the maximum predicted total subsidence of 415 mm. The maximum observed total tilt due to the extraction of LW12, 11 and 20 is 5.0 mm/m between survey mark EF44 and EF45, which is greater than the maximum predicted total tilt of 1.7 mm/m. The maximum observed total strain due to the extraction of LW12, 11 and 20 is a compressive strain of 1.1 mm/m which occurs between survey pegs EF58 and EF59, which are located over Longwall 20. Measured strains along the EF Line are predominantly less than 0.5 mm/m, for both compressive and tensile strain, which is similar to the order of survey tolerance.

Whilst the observed movements exceeded those predicted, it is noted that the monitoring line crosses the corner of Longwall 20, where the subsidence parameters are the most difficult to predict. The maximum predicted total subsidence directly above Longwall 20, due to the extraction of Longwalls 12, 11 and 20, was around 500 mm. The maximum observed total subsidence along the EF Line, of 570 mm, therefore, exceeds the maximum predicted total subsidence anywhere above the longwall by around 15 %.

The maximum observed total tilt along the monitoring line exceeded that predicted, as more low level subsidence was predicted to occur outside the extent of Longwall 20, as a result of the reactivation of the existing overlying workings and the adjacent longwalls. The observed subsidence profile indicates less reactivation of the existing workings, outside the extents of Longwall 20, than was predicted (i.e. predicted subsidence profile was broader than that observed). The maximum predicted total transverse tilt above Longwall 20, due to the extraction of Longwalls 12, 11 and 20, was around 3.5 mm/m. The maximum observed total tilt along the EF Line, of 5.0 mm/m, therefore, exceeds the maximum predicted total transverse tilt by around 1.5 mm/m.

For the EF survey line, the maximum observed total subsidence due to the extraction of Longwalls 12, 11 and 20 was 570 mm at survey mark EF49, which is greater than the maximum predicted total subsidence of 415 mm.

The maximum observed total strain due to the extraction of Longwalls 12, 11 and 20 is a compressive strain of 1.1mm/m which occurs between survey pegs EF58 and EF59. Measured strains along the EF survey line are predominately less than 0.5 mm/m, for both compressive and tensile strains, which is similar to the order of survey tolerance.

The maximum observed total tilt due to extraction of Longwalls 12, 11 and 20 is an incremental tilt of 5.0 mm/m and is greater than the predicted maximum of 1.7 mm/m.

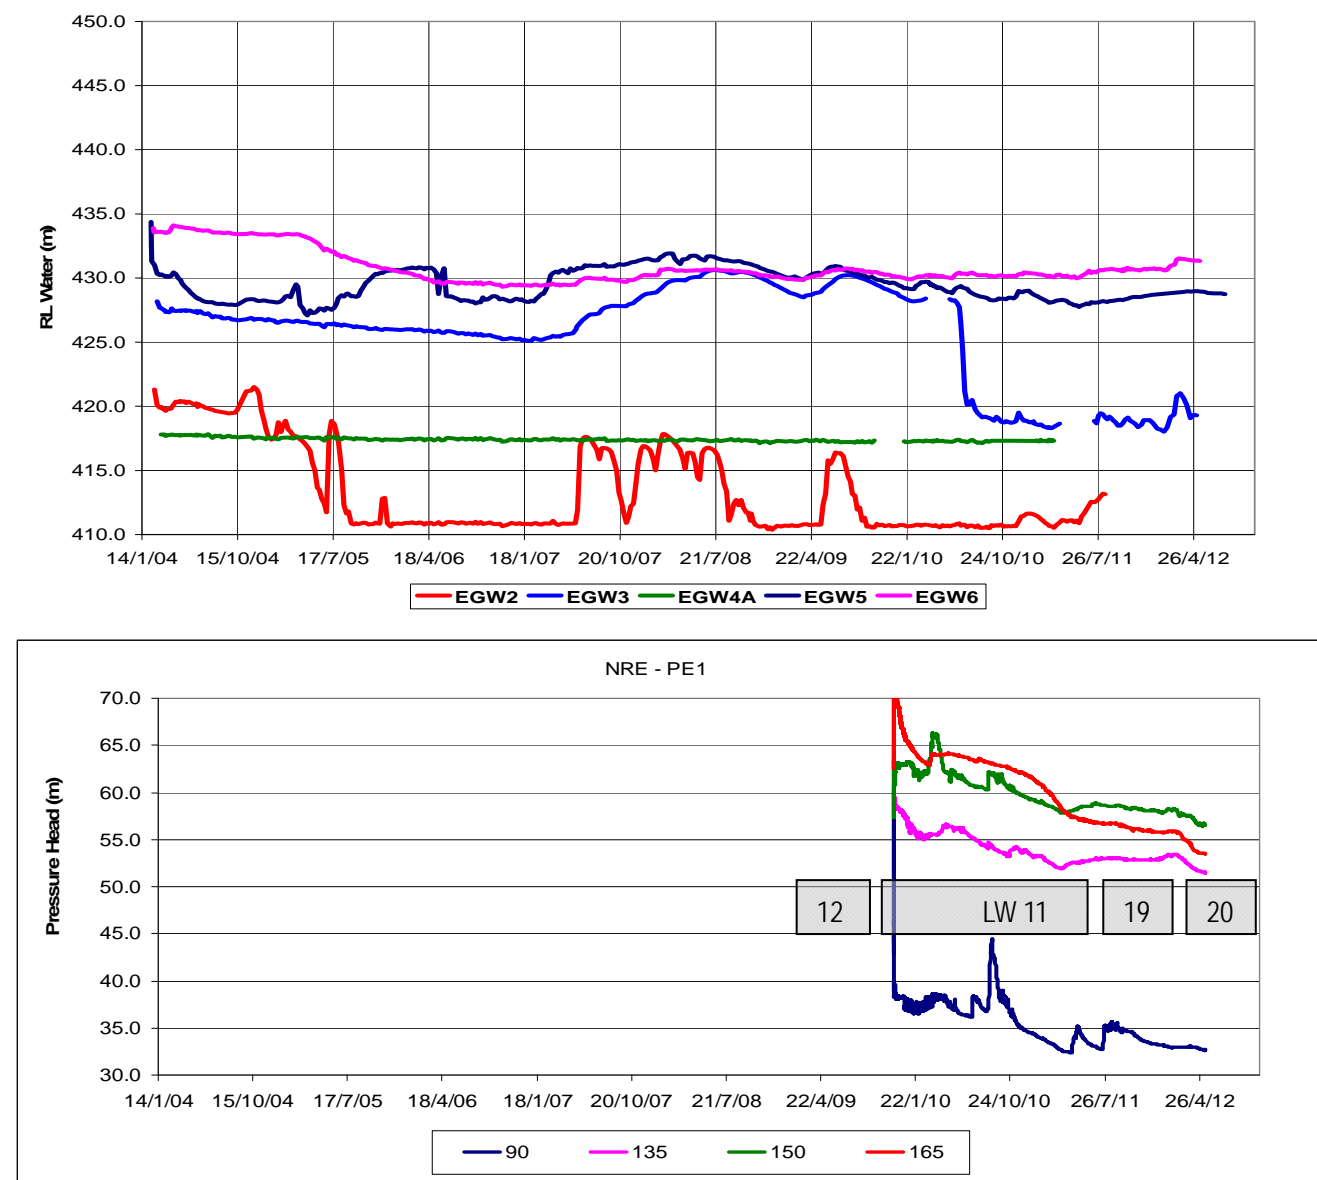
**Figure 1 Groundwater Levels and Head Pressure**

A gradual depressurisation has been monitored in the Hawkesbury Sandstone (90m and 135m), Bald Hill Claystone (150m) and upper Bulgo Sandstone (165m) since the VWP array was installed in late November 2009 as shown in **Table 5**.

No basement groundwater level related TARP triggers were exceeded during extraction of Longwalls 11, 12, 19 or 20.

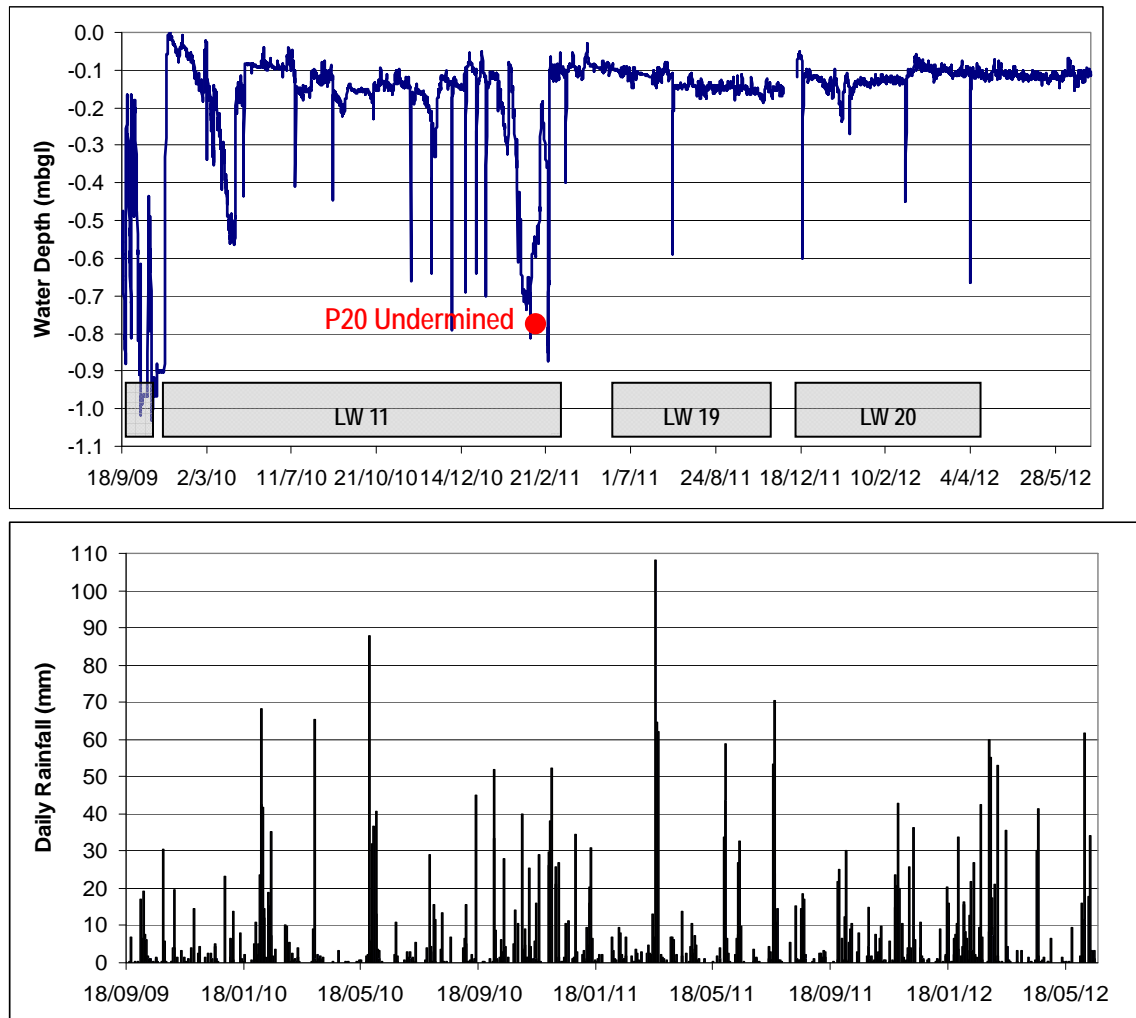
**Figure 2 Swamp P20 Groundwater Level and Rainfall**

It should be noted, however, that water level falls of up to 0.55m were previously observed, prior to extraction of Longwall 11 in the vicinity of swamp piezometer P20.

No evidence of swamp desiccation that could potentially be due to mining induced subsidence in Swamp 20 has been observed.

No swamp groundwater level TARP trigger levels were reached or exceeded during extraction of Longwalls 11, 12, 19 or 20 and no ameliorative actions are required.

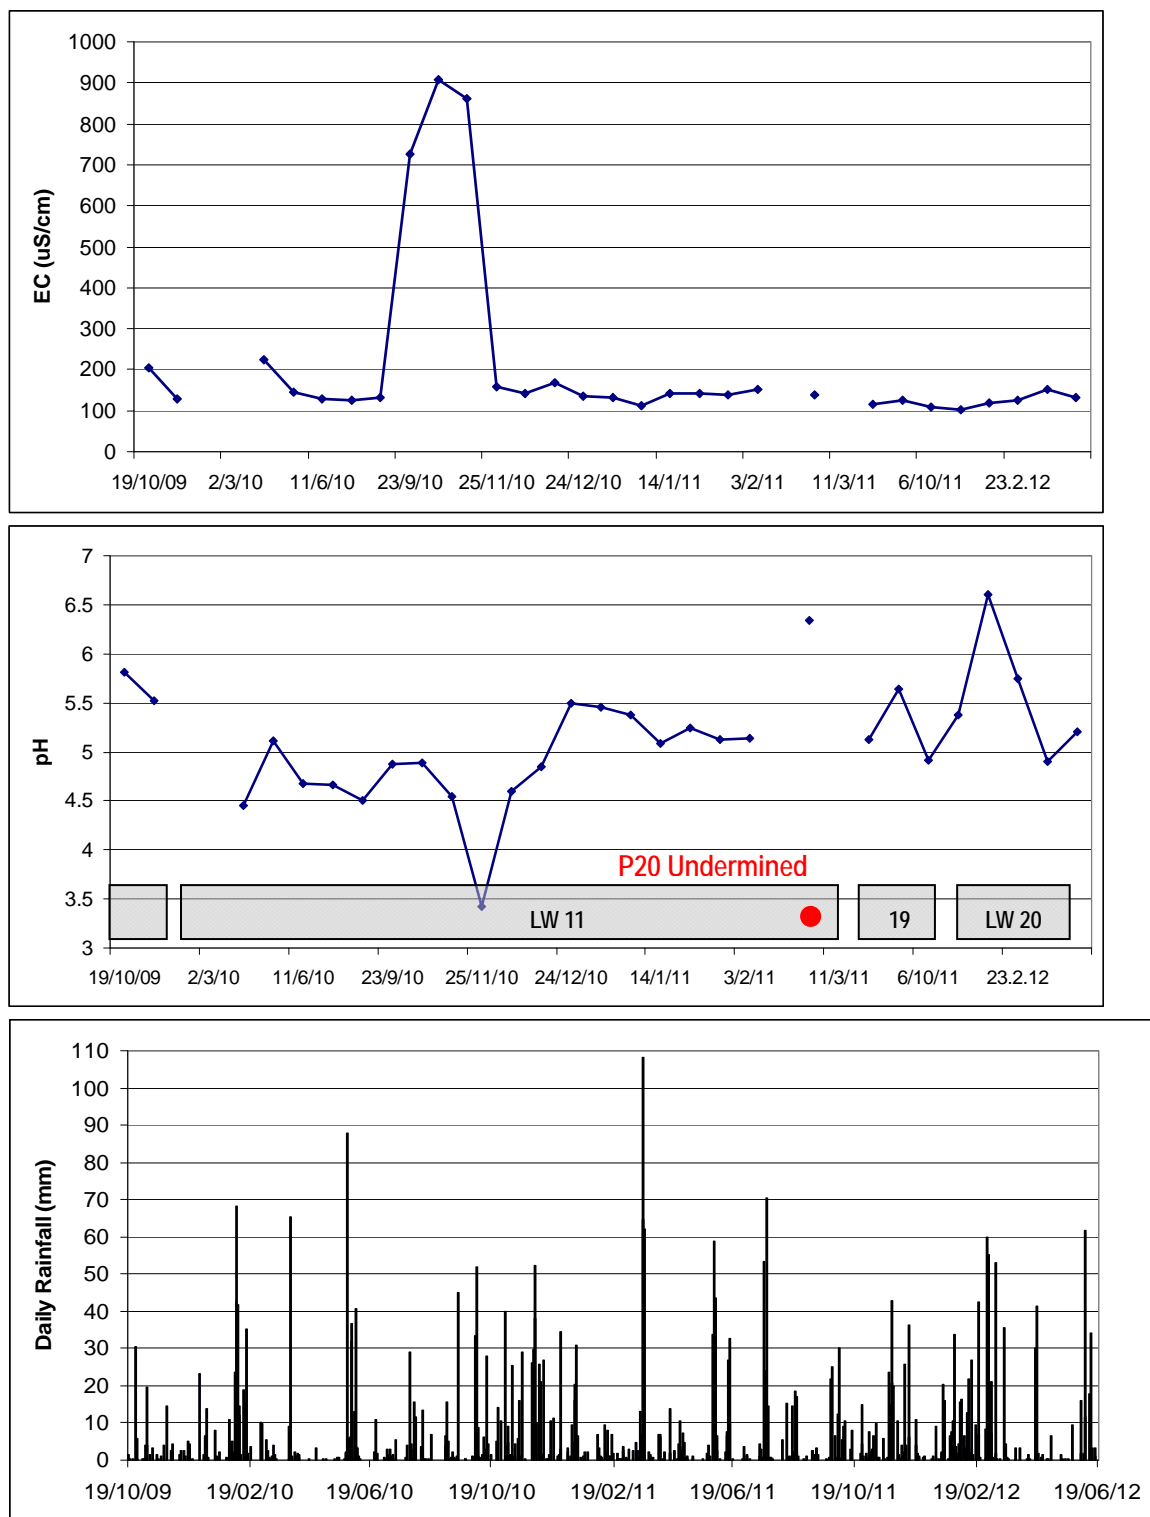
Figure 3 Swamp Piezometer P20 EC, pH and Rainfall

No adverse effects on groundwater quality in Swamp 20 due to subsidence effects from extraction of Longwalls 11, 12, 19 or 20 have been observed.

No TARP water quality trigger levels have been exceeded and no ameliorative actions are required.

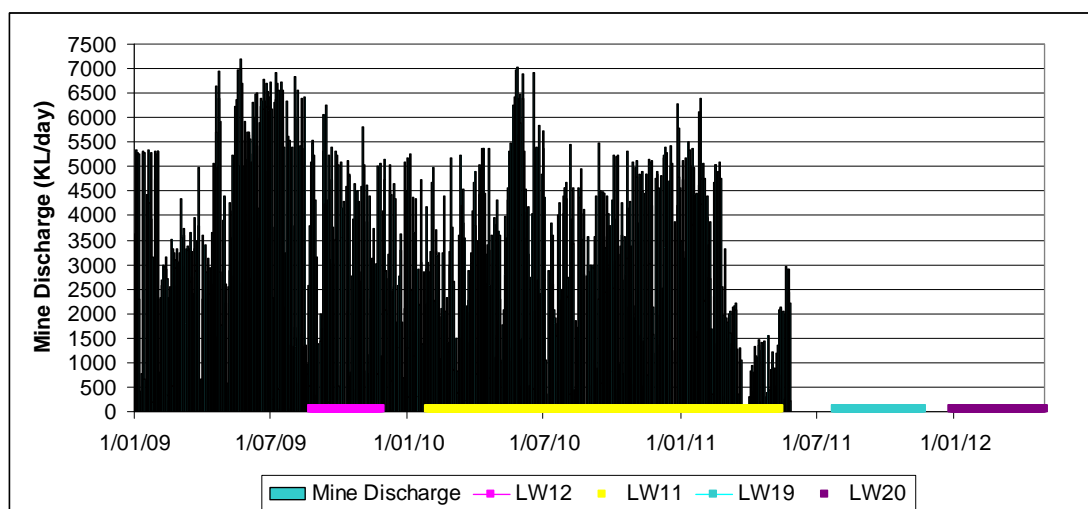
**Figure 4 Wongawilli Workings Mine Water Extraction**

A plot of mine water discharges from the Wongawilli workings, which includes the decommissioned Eloura and associated workings, is shown in **Figure 4**.

The significant drop off in water pumped out in the last few months of pumping is due to access to underground water storages being blocked due to panel development for LW19 as well as a shortage of water in the underground during extraction of Longwalls 19 and 20.

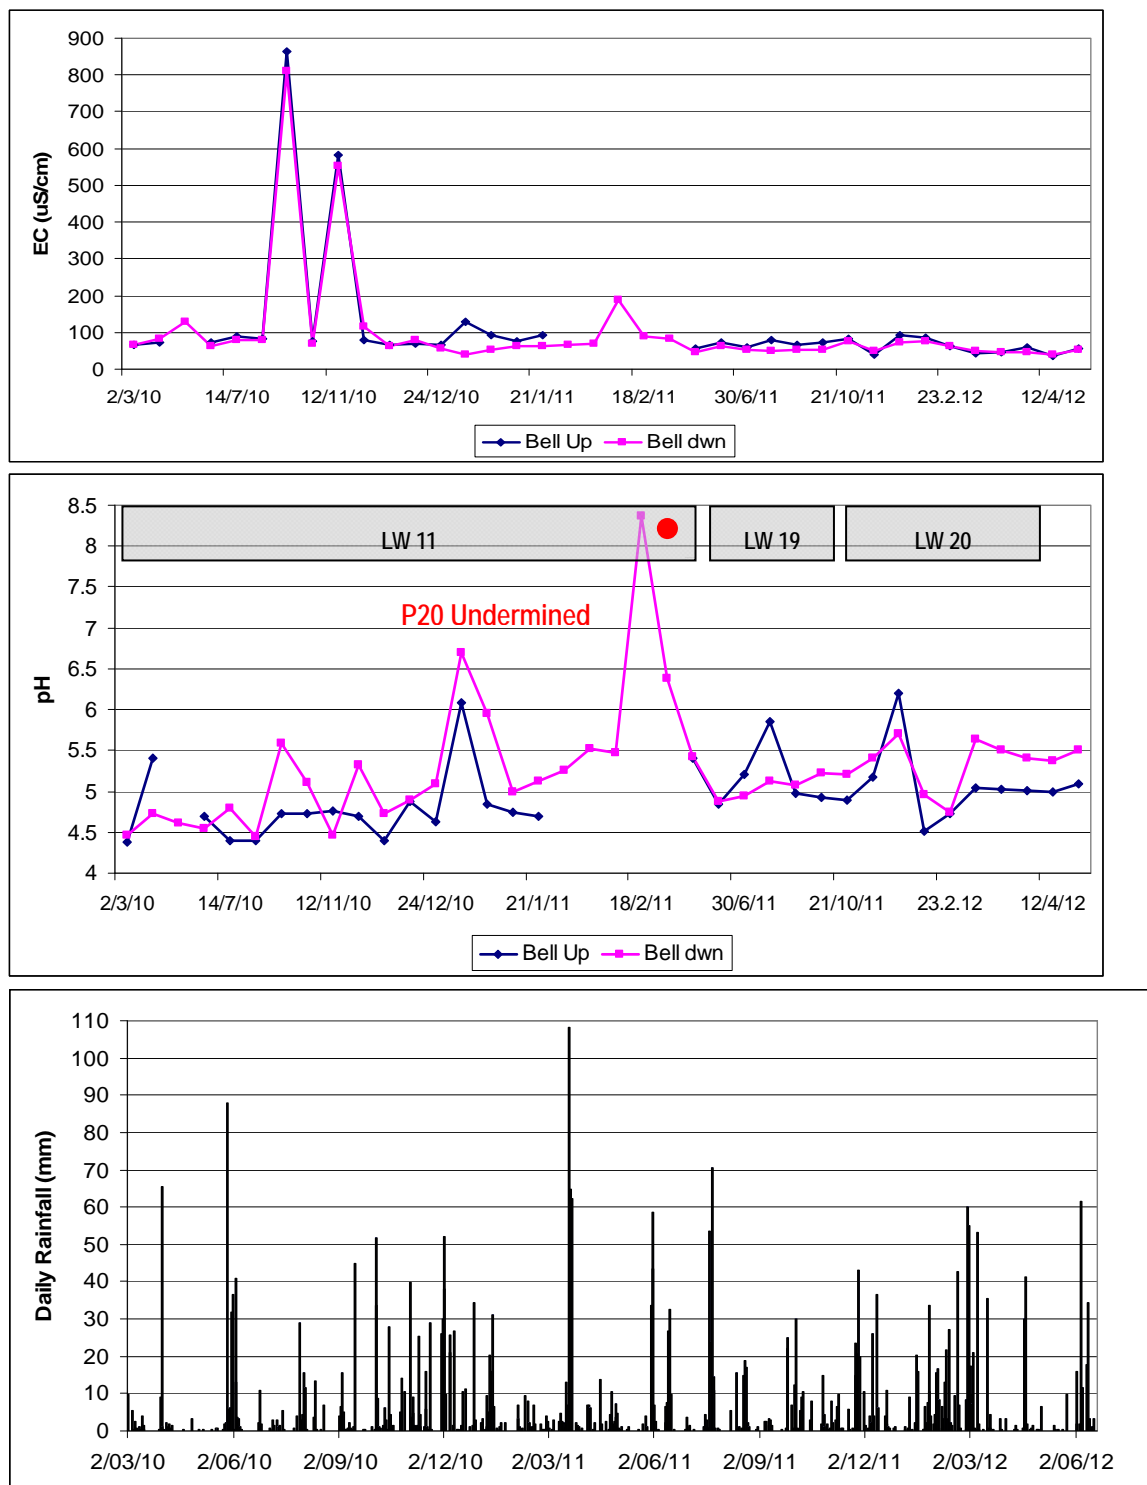
**Figure 5** Bellbird Creek EC, pH and Rainfall

response to the quantum and duration of rainfall recharge in the catchment were observed as shown in **Figure 5**.

It should be noted that the two salinity peaks observed in mid to late 2010 were not related to subsidence of Bellbird Creek, as the channel had not been undermined at that time.

The stream water quality related TARP trigger levels in Bellbird Creek were not exceeded during extraction of Longwalls 11, 12 19 and 20.
