Site	Wongawilli Colliery	DOC ID	
Type	Report	Date Published	16/01/2015
Doc Title	Annual Review/Annual Environmental Management Report

Wongawilli Colliery
Nebo Area Project Approval (MP 09_161)

ANNUAL REVIEW/ANNUAL ENVIRONMENTAL MANAGEMENT REPORT
(1 JULY 2013 – 30 JUNE 2014)

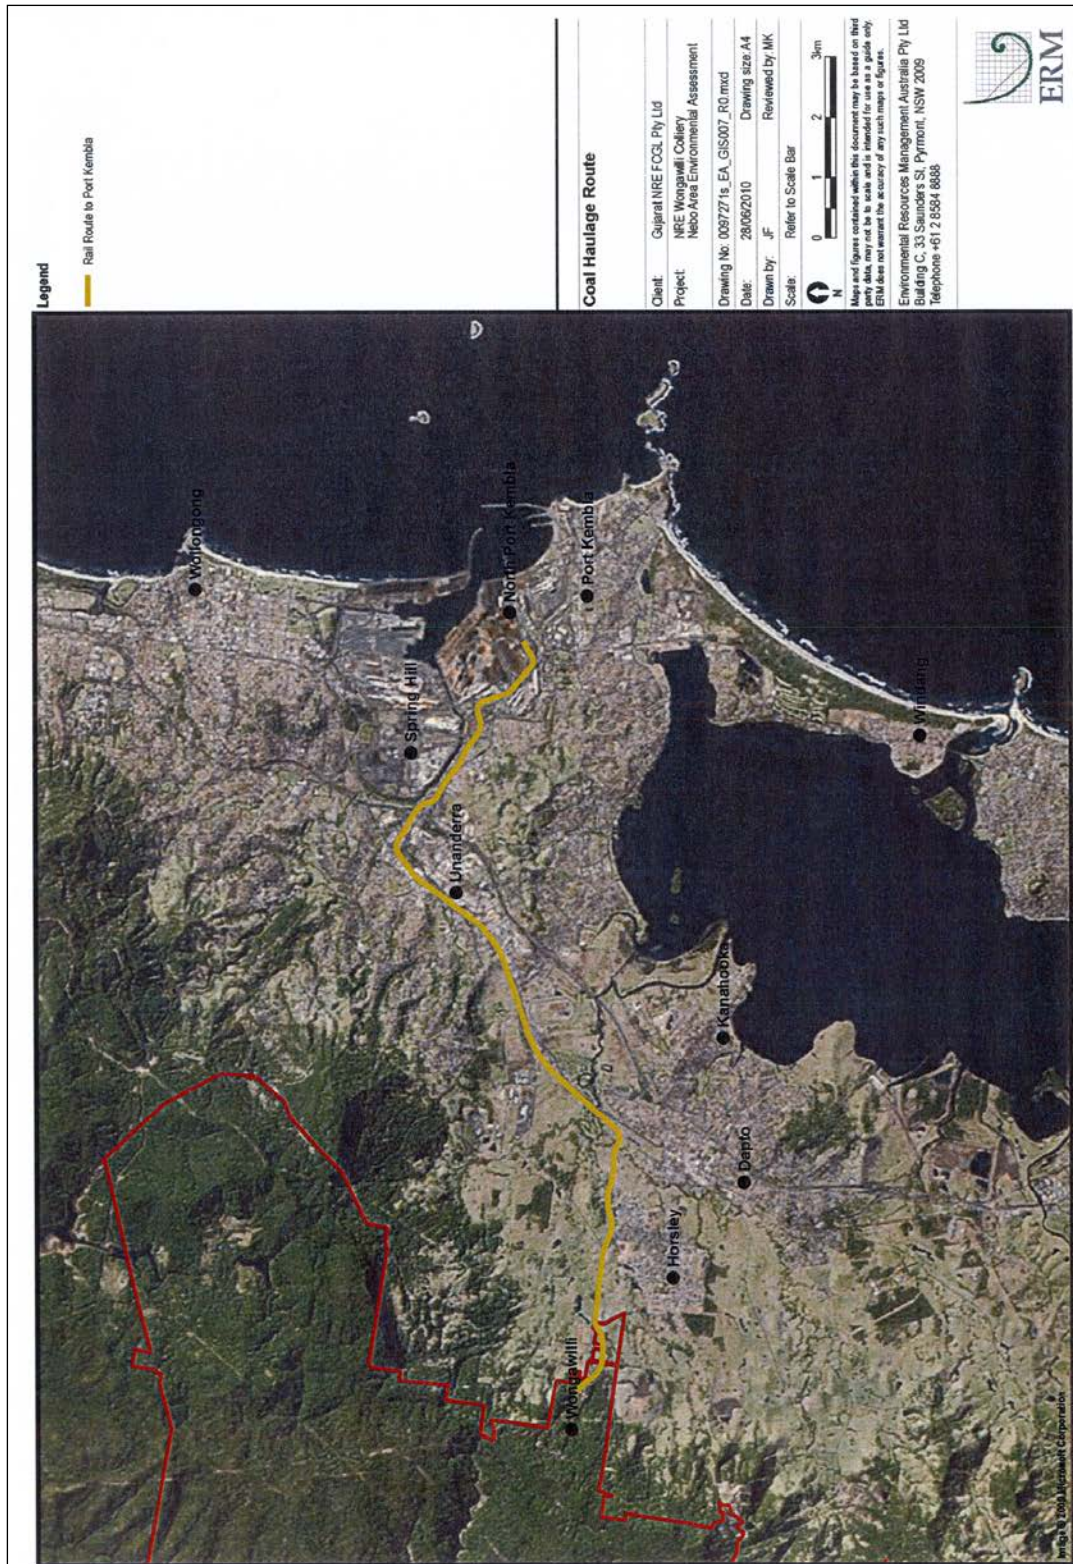
Figure 7 - Coal Haulage Route from Wongawilli Colliery to PKCT

A private rail spur line from the Wongawilli Colliery stockpile area to the Illawarra Railway forms a transport link for coal supply to the PKCT. This transport route is shown in **Figure 7**.

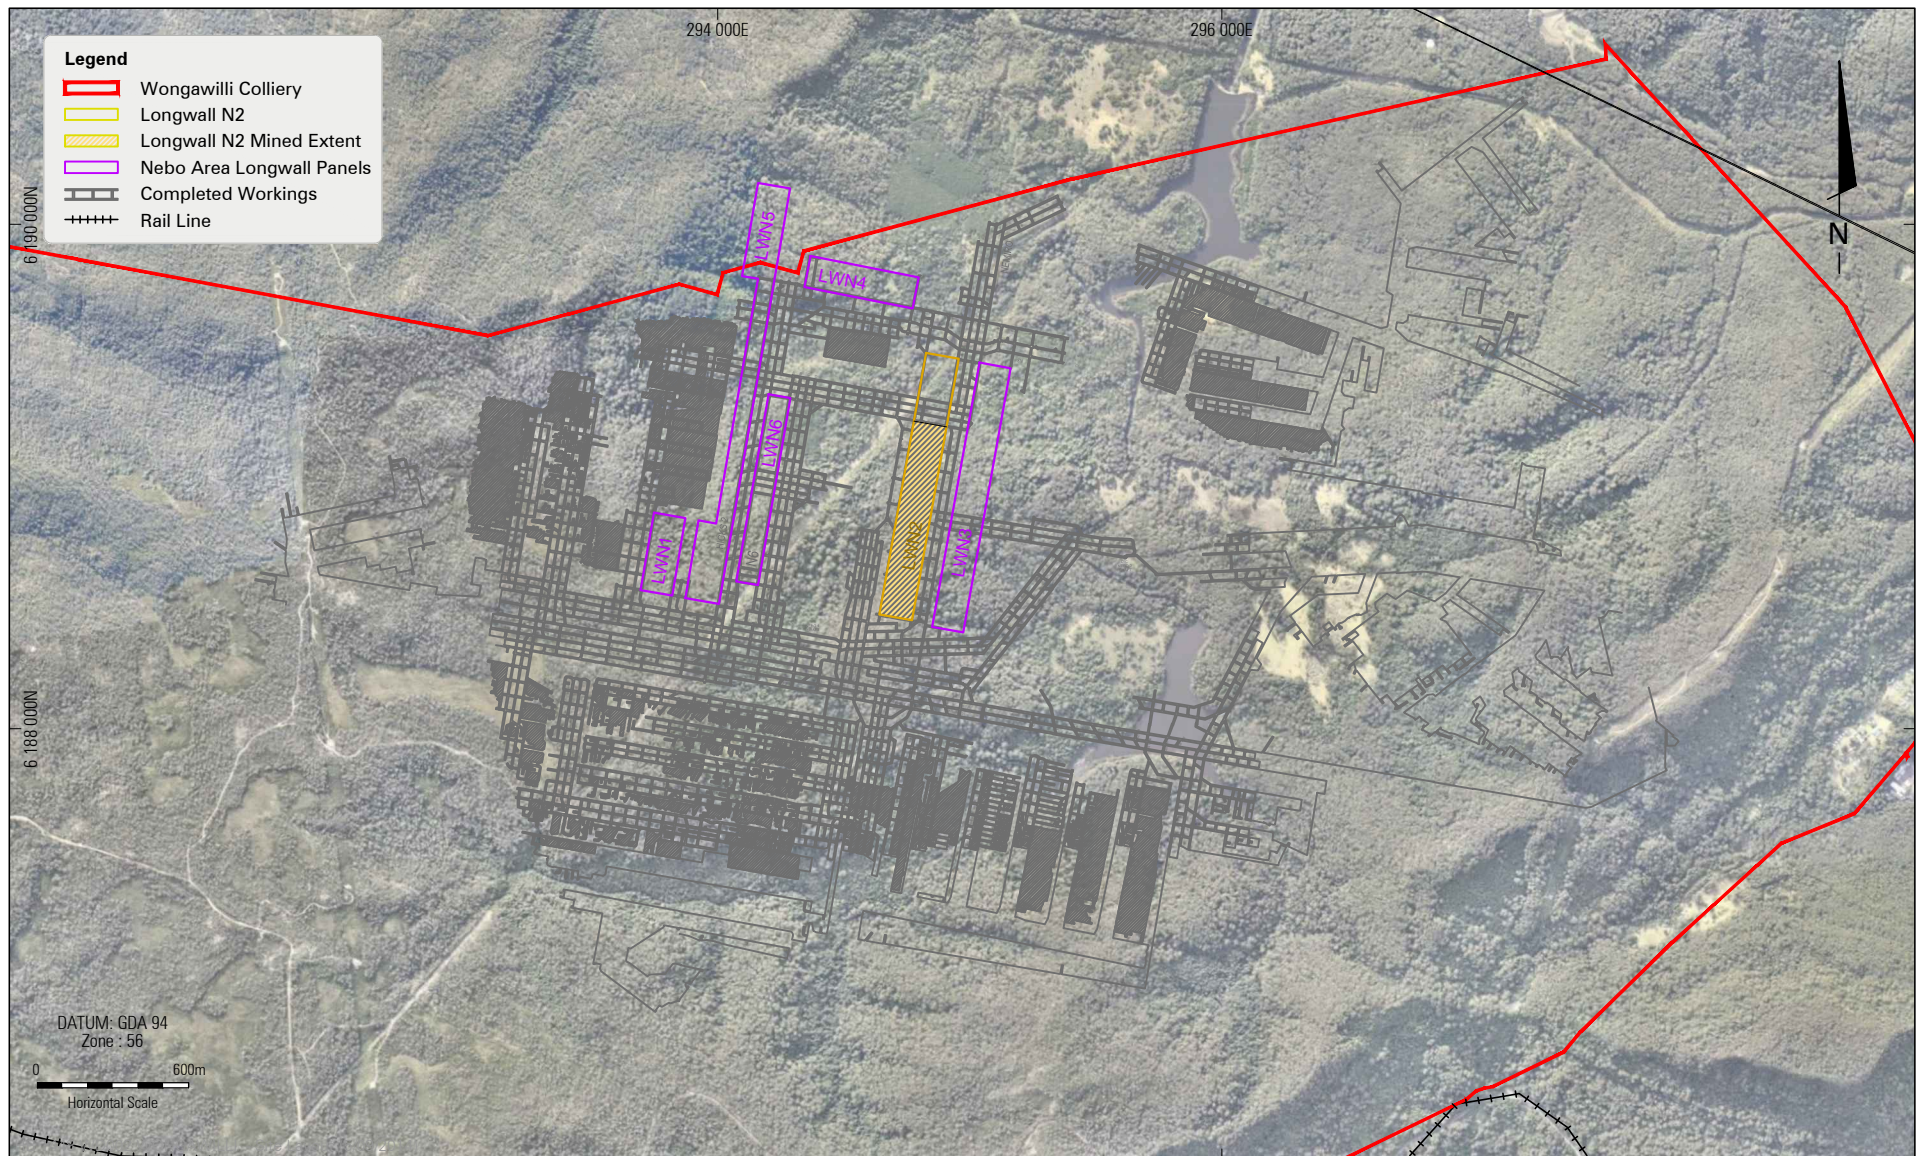
FIGURE 1

Regional Locality

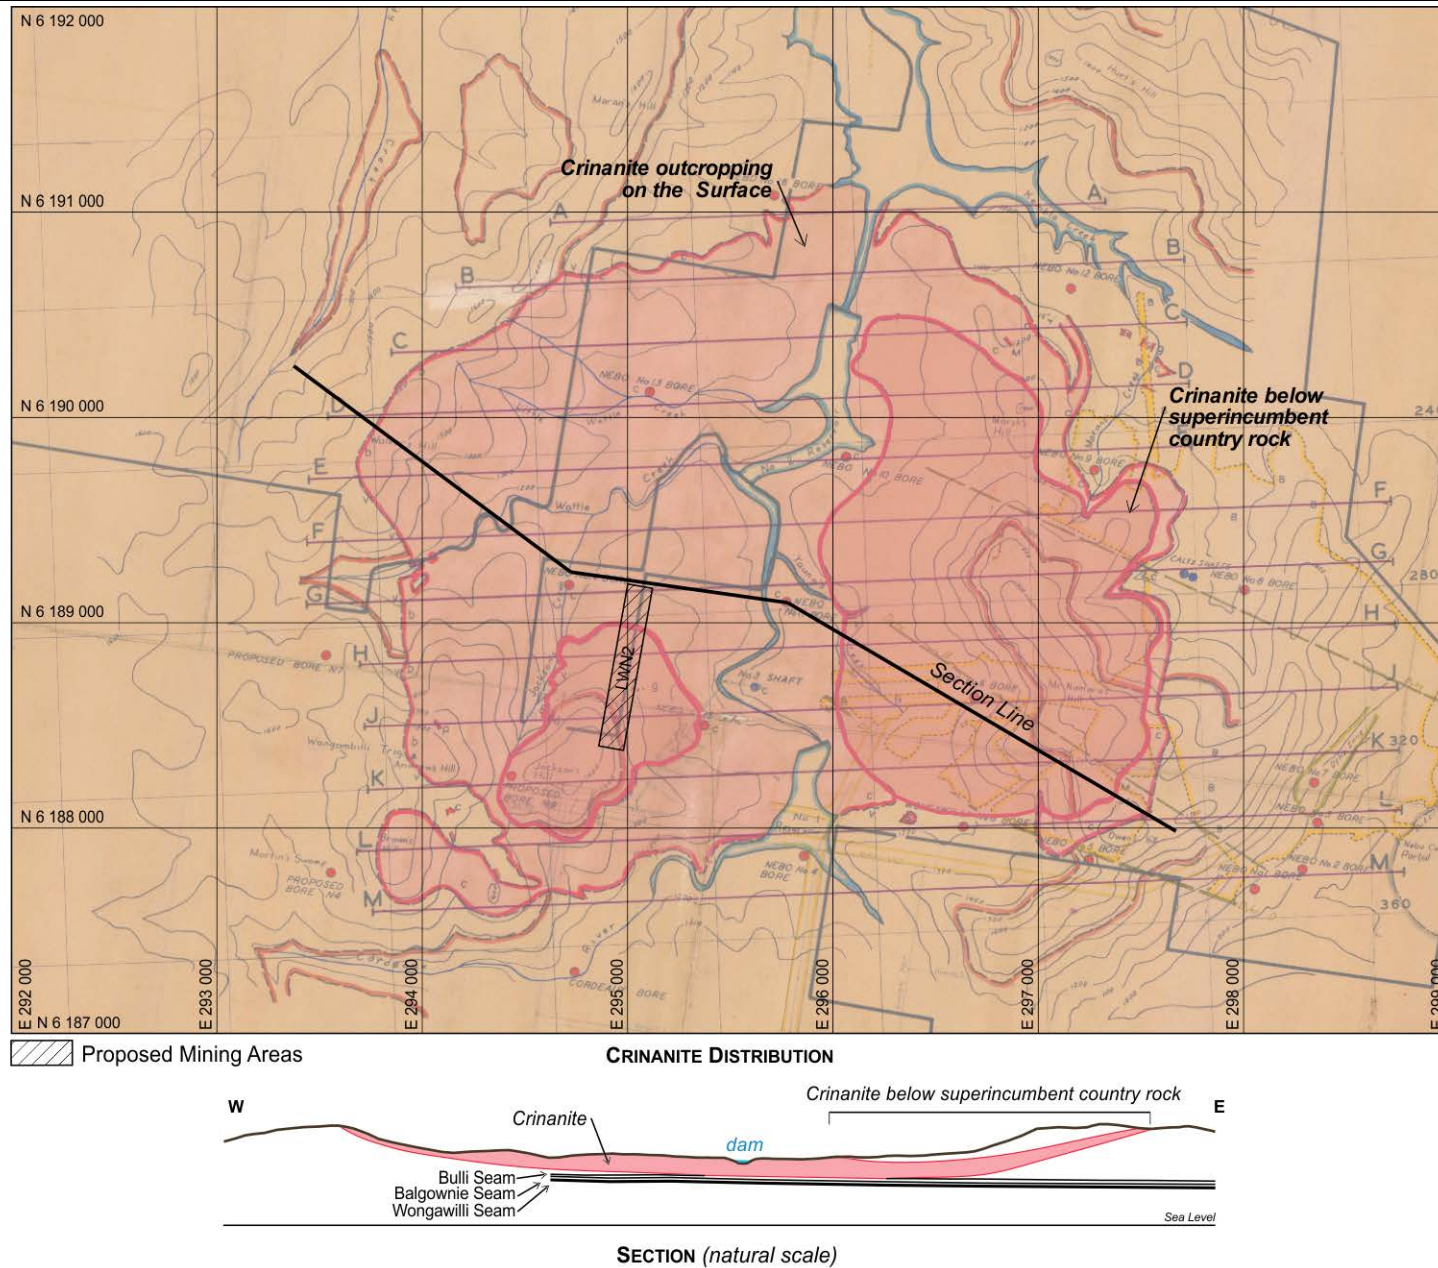
Figure 2: Crinanite distribution based on AIS Coal Geology Plan S3-64 (accuracy is estimated to be generally better than 50m).

The overburden strata in the general vicinity has been intruded by a crinanite (dolerite) sill as shown in Figure 2. This crinanite intrusion ranges in thickness from 55m to 98m generally thickening toward the south and east.

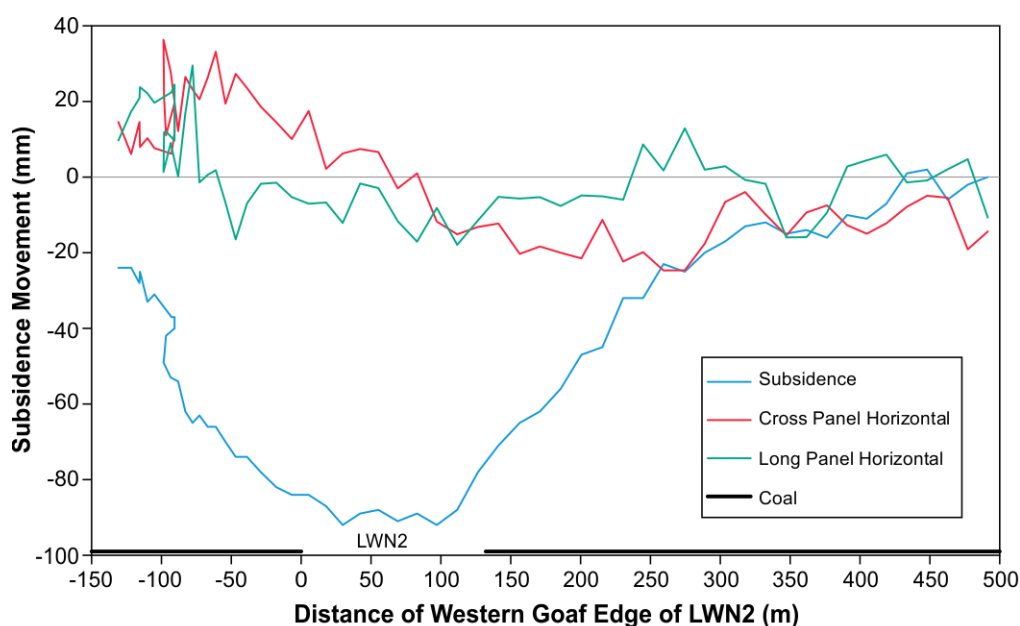
Figure 3: 300 Line subsidence movements measured above LWN2.

Figure 3 shows a plot of the subsidence movements measured on the 300 Line subsidence line with the horizontal axis plotted as distance relative to the western edge of the panel as if the line were located perpendicular to the panel. All three components of movement are plotted with the two horizontal components resolved into cross panel movements and along panel movements positive to the east and the north (i.e. the direction of mining).

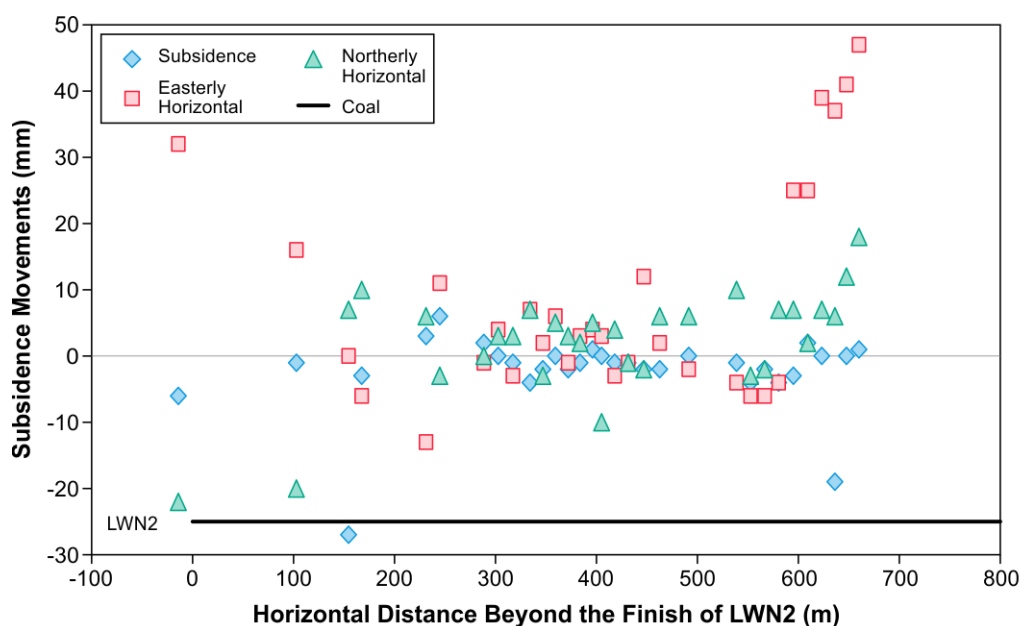
Figure 4: 200 Line subsidence movements measured north of LWN2.

In general, the subsidence movements measured on 200 Line are less than survey tolerance. The eastward horizontal movement of 30mm observed on Peg NM2001 is consistent with the cross panel movements observed on 300 Line. The vertical subsidence is only just greater than survey tolerance but is also consistent with the 300 Line data recognising that subsidence is likely to be reduced around the end of the panel.

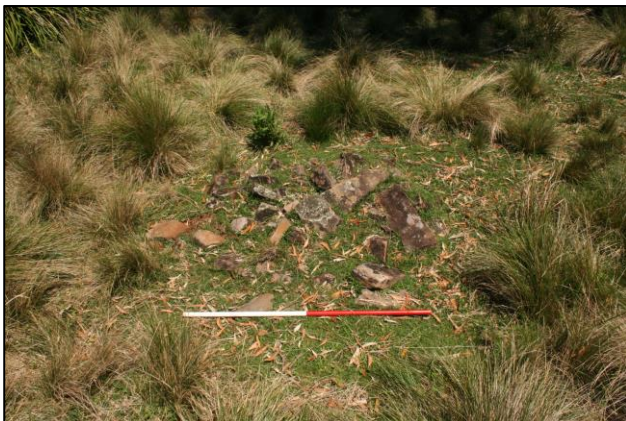
Plate 1: Baseline recording of Cordeaux River Historic 3 – detailed view of building foundations

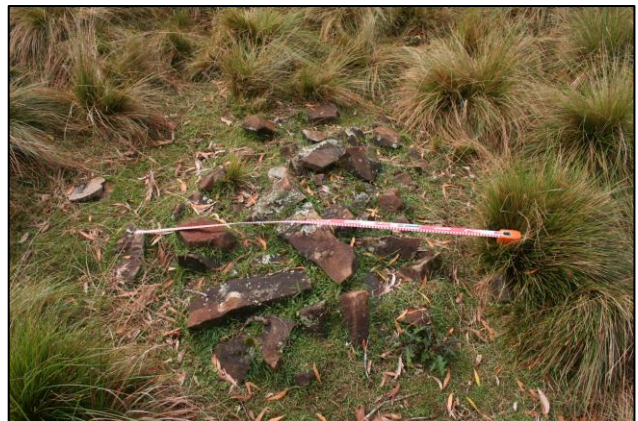
Plate 2: Most recent monitoring at Cordeaux River Historic 3 – detailed view of building foundations

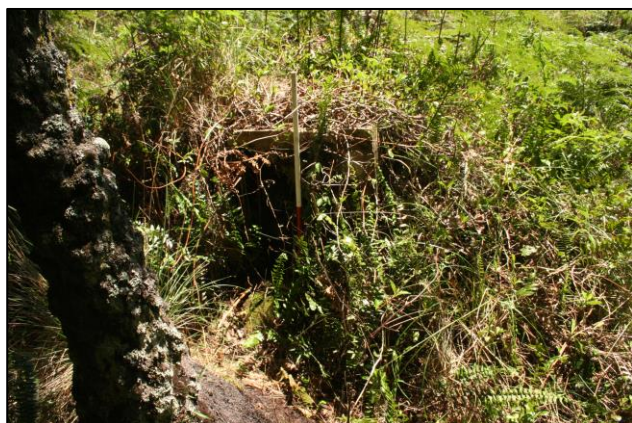
Plate 3: Baseline recording of Cordeaux River Historic 3 –concrete blocks view south-west

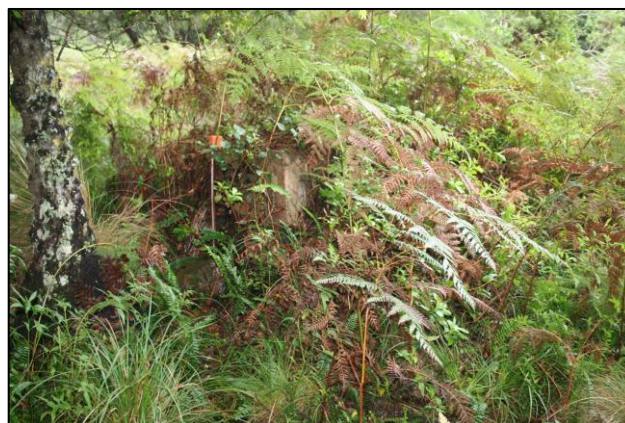
Plate 4: Most recent monitoring at Cordeaux River Historic 3 –concrete blocks view south-west

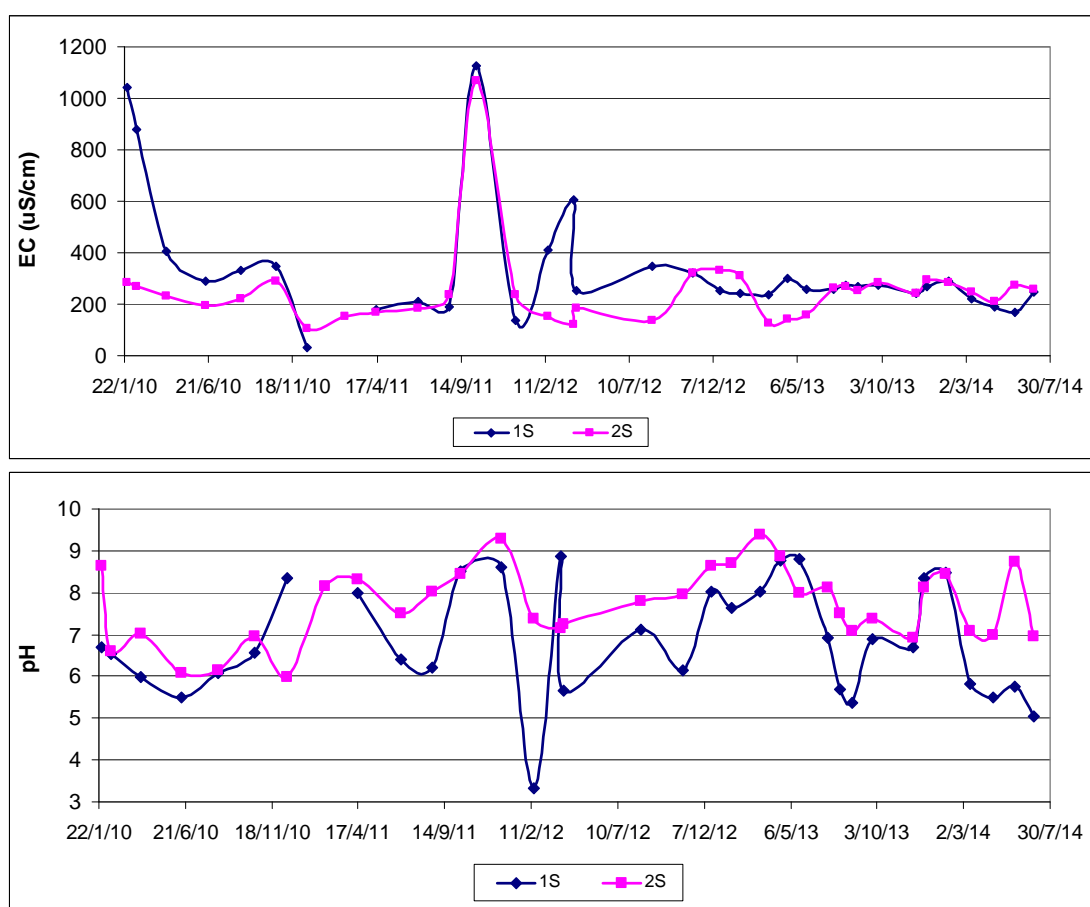
Figure 9 Alluvium / Colluvium pH and EC

It should be noted that due to the high pH (6 - 9.5 for 1S, 5 – 9 for 2S) as a result of cement contamination either during piezometer installation or sampling of these waters, they contain unnaturally elevated metals due to their high solubility of the metals in the highly alkaline conditions.

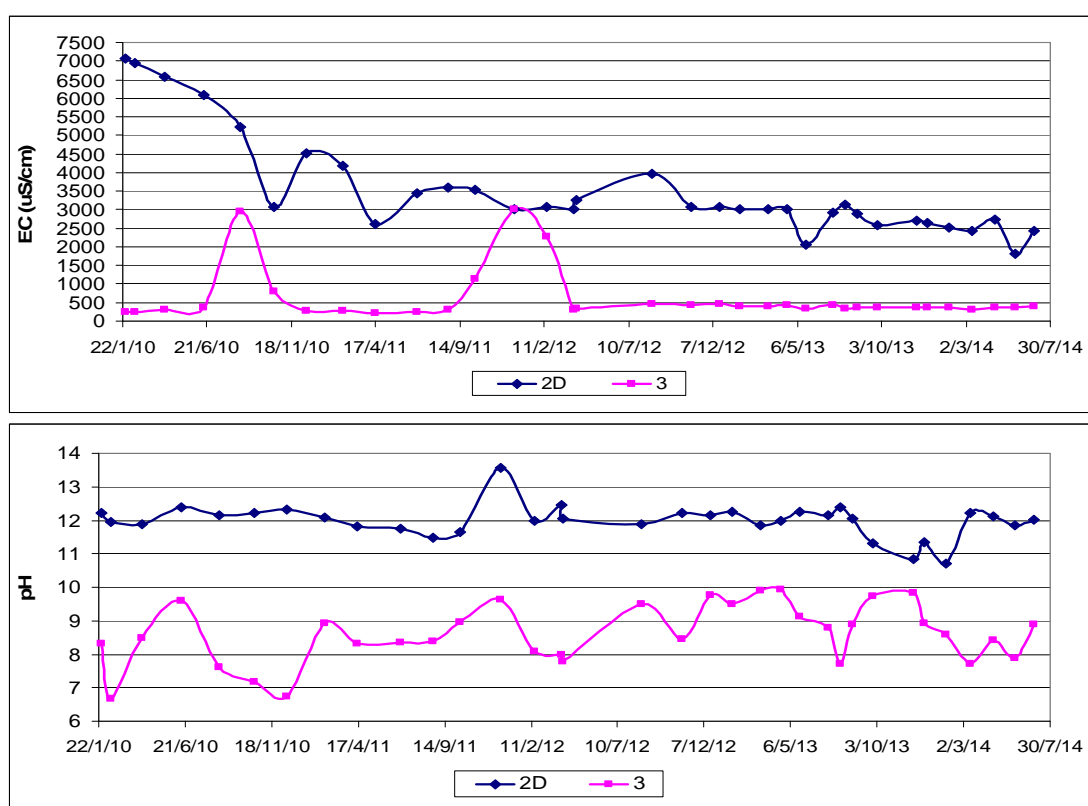
Figure 10 Crinanite pH and EC

It should be noted that the high pH in the piezometers is due to cement contamination either during piezometer installation or sampling of these waters, and that they contain unnaturally elevated metals due to their high solubility of the metals in the strongly alkaline conditions.

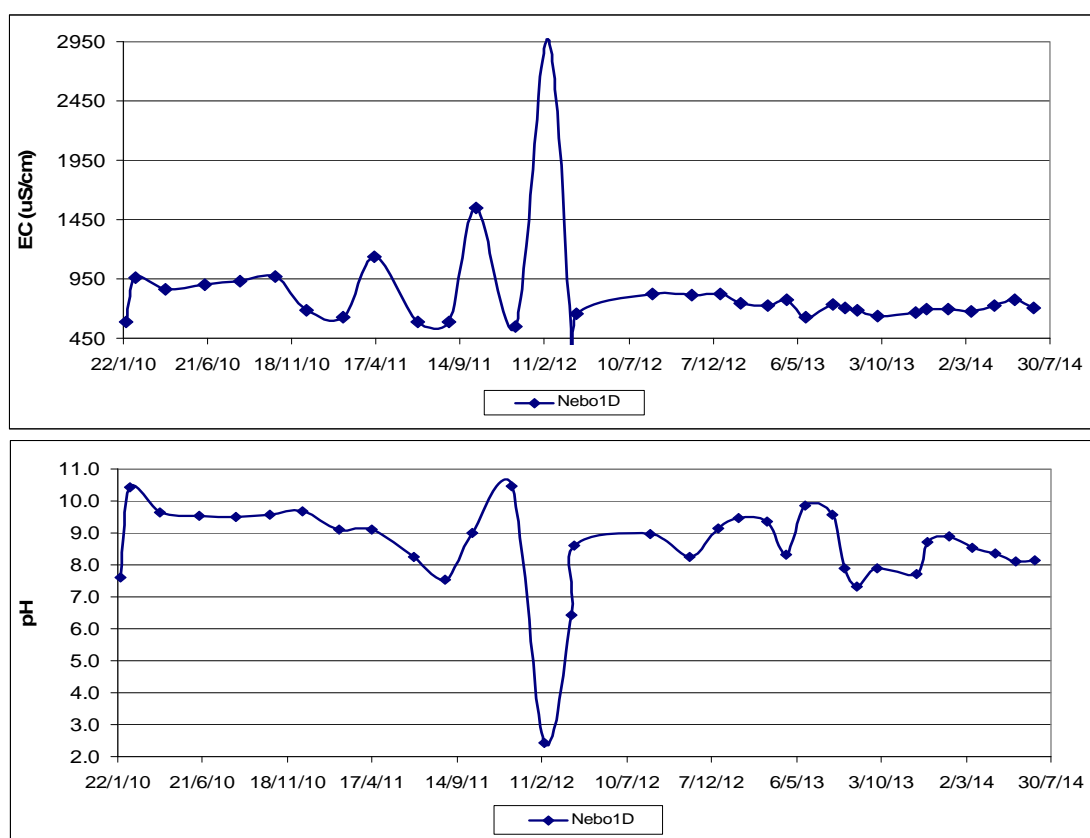
Figure 11 Narrabeen Group pH and EC

It should be noted that the high pH in the piezometer is due to cement contamination either during piezometer installation or sampling of these waters, and that it contains unnaturally elevated metals due to the high solubility of the metals in the strongly alkaline conditions.

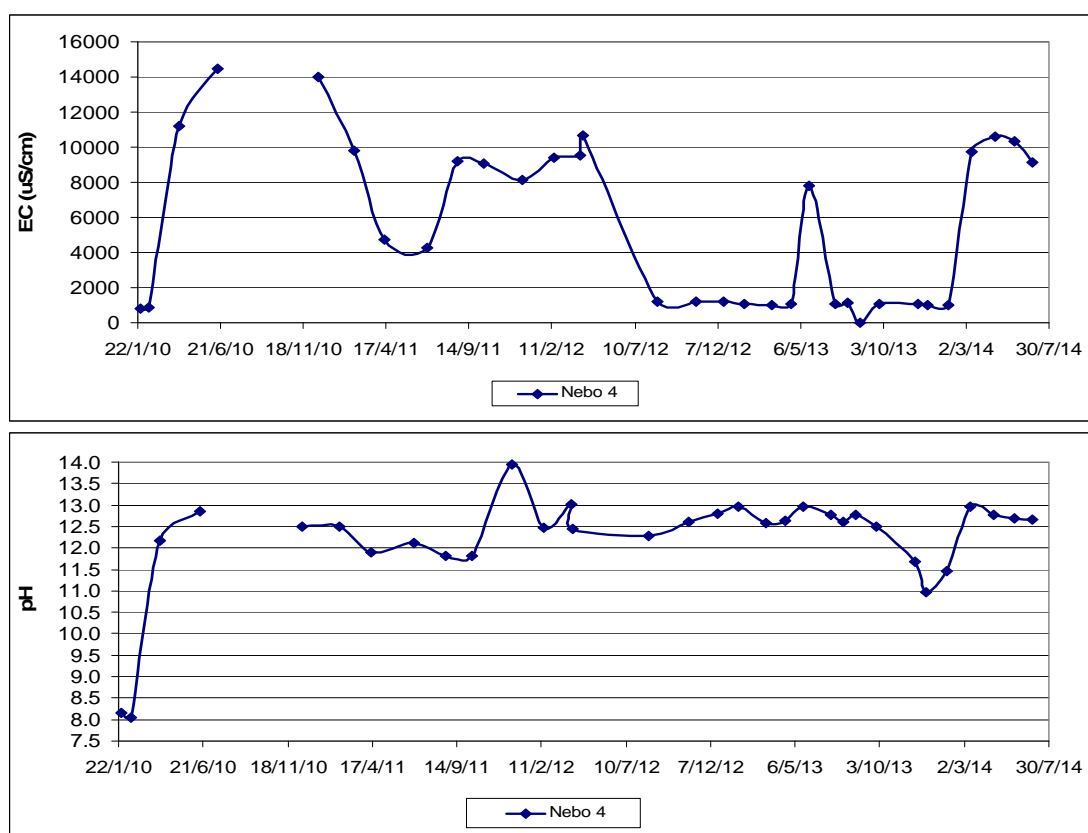
Figure 12 Bulli Seam pH and EC

It should be noted that the high pH in the piezometer is due to cement contamination either during piezometer installation or sampling of these waters, and that it contains unnaturally elevated metals due to the high solubility of the metals in the strongly alkaline conditions.

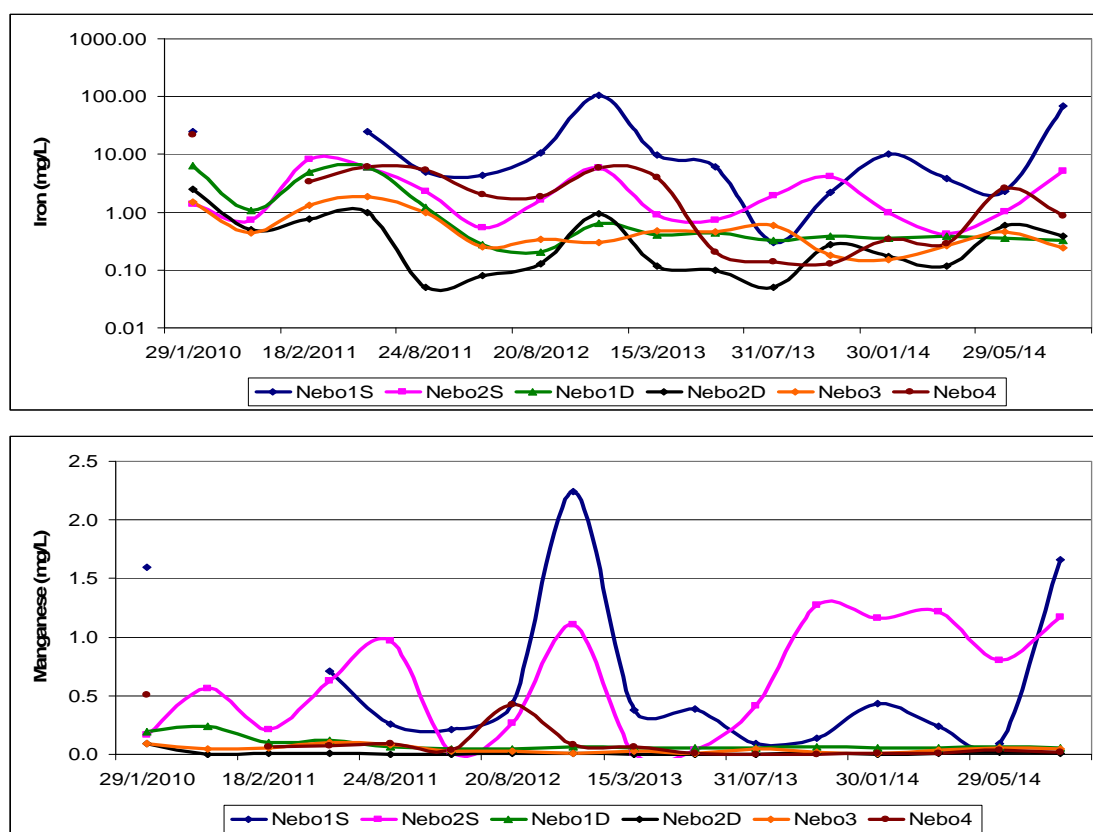
Figure 13 Iron and manganese (mg/L)

The piezometers at Nebo also contain elevated iron and manganese due to their solubility in the highly alkaline water, however no increasing or decreasing trend in these metals is evident during the sampling period as shown in **Figure 13**.

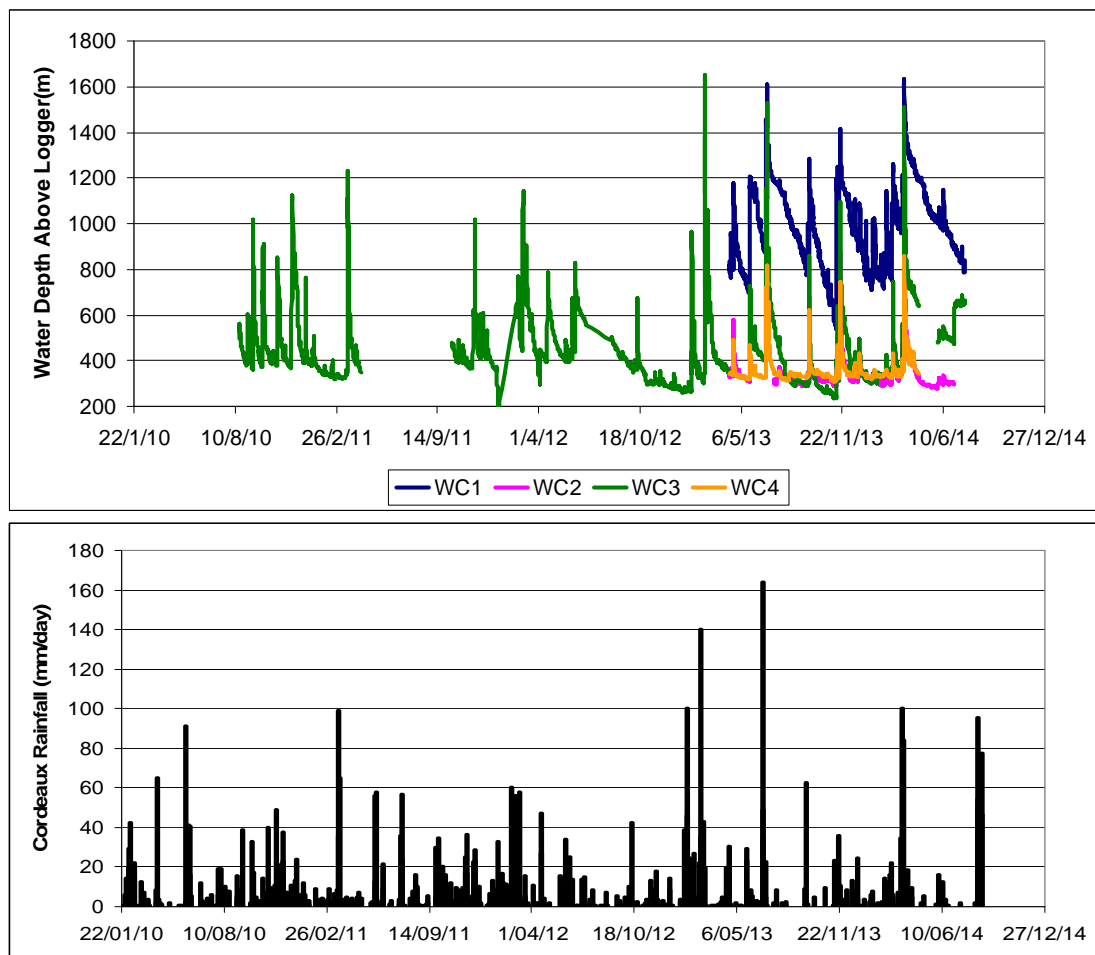
Figure 14 Nebo Stream Water Level

Visual observation has not indicated any adverse effects on Little Wattle Tree Creek stream flow or pool levels.

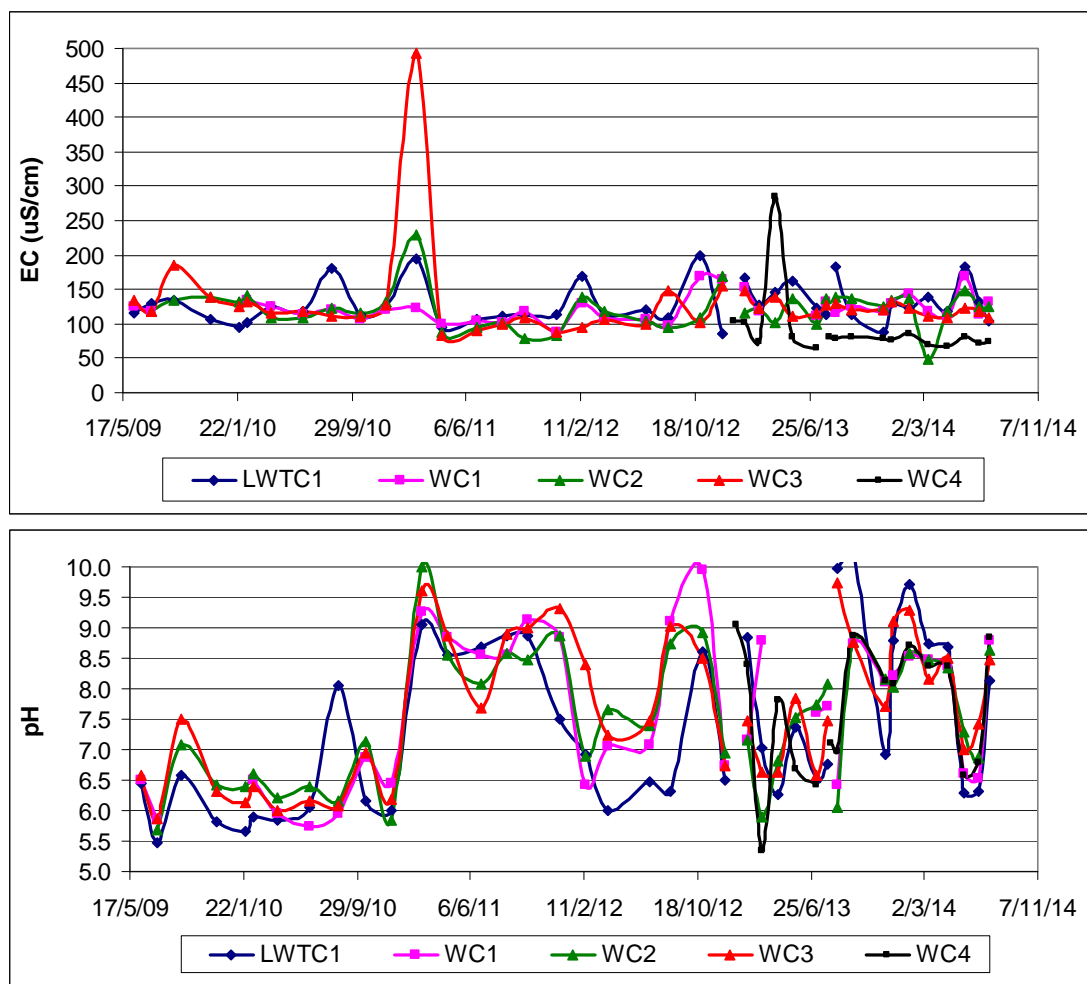
Figure 15 Stream Salinity and pH

The field and laboratory data supplied by WCL indicates that the creek salinity generally varies from 50 – 250uS/cm, whereas the pH, which is naturally between 5.5 and 8, is shown as reaching up to 10; however the more alkaline readings are a result of cement contamination of the pH probe.
